# Access Compliance Report

## Public Rights-of-Way

### (Curb Ramps)

| Intersection ID: 43374 | Main Street: COOPER'S RIDGE LN | Cross Street: BERNBROOKE_SHADOW LN | Location: W |

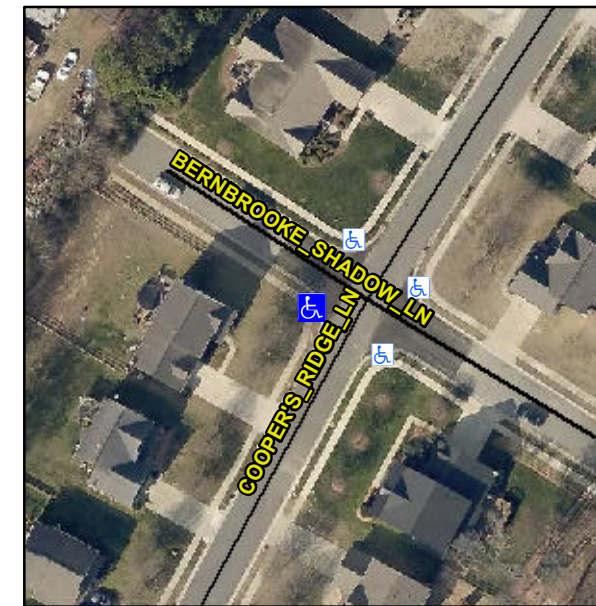
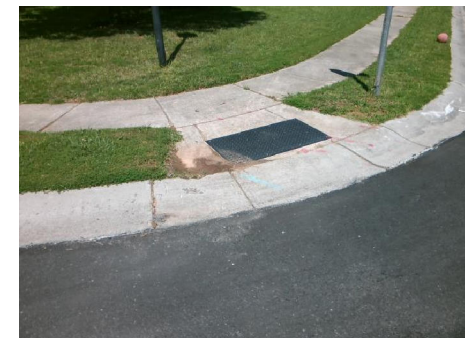
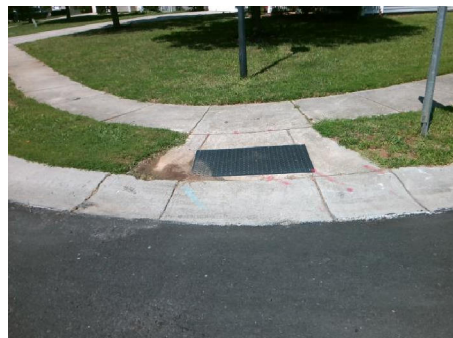
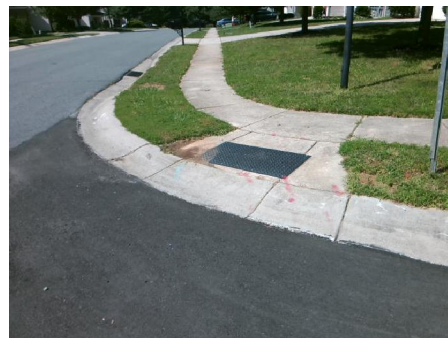
| ADA ID: 5A3A7B1767BD | Ramp Type: BlendTrans1 | Initial Pass/Fail: Fail | Overall Compliance: No |

**Not Found, R304.5.1, R304.5.3**

| Compliance | Description | Data | Compliance | Description | Data |
|---|---|---|---|---|---|
| N/A | Ramp Length (in) | 47.5 | Yes | BlendTrans Slope (%) | 3.1 |
| No | Ramp Width (in) | 37.0 | No | BlendTrans XSlope (%) | 5.6 |
| | | | No | Curb Slope (%) | 12.5 |

**Remove & Replace Curb Ramp With Two New Directional Ramps or Equivalent.**

Total Cost: \$ 3200.00
