Access Compliance Report

Public Rights-of-Way

(Curb Ramps)

Intersection ID: 11556	Main Street: HARRILL_ST	Cross Street: PARKWOOD_AV	Location: SW
ADA ID: 5A3FC3C4DD6B	Ramp Type: BlendTrans1	Initial Pass/Fail: Fail	Overall Compliance: No
		Severity Score: 10

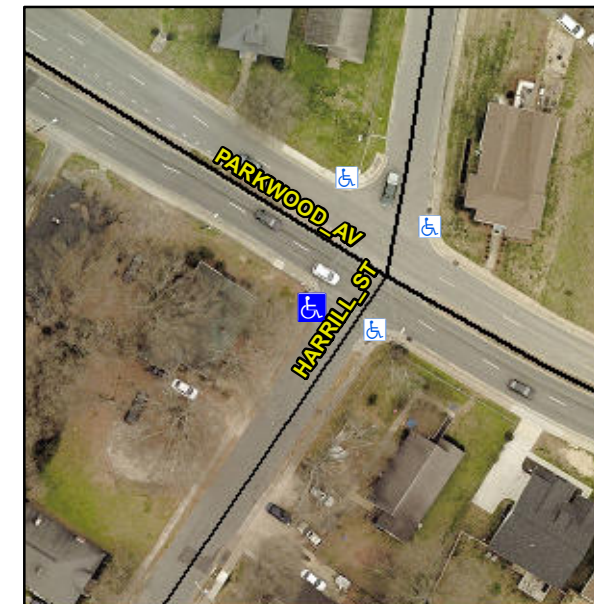
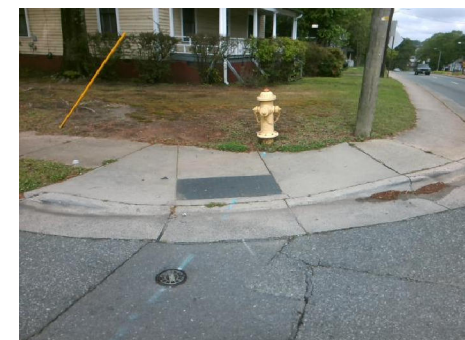
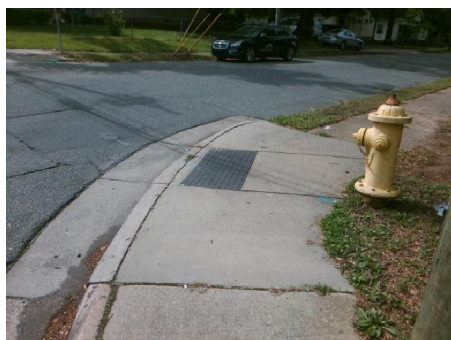
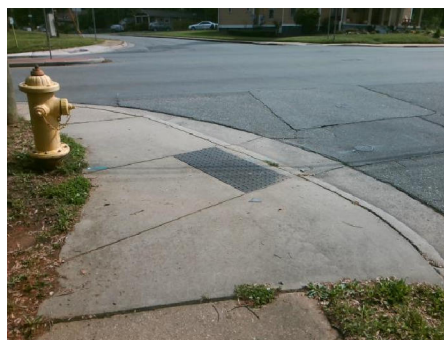
Not Found, R304.5.1, R304.5.3

Compliance	Description	Data	Compliance	Description	Data
N/A	Ramp Length (in)	67.0	Yes	BlendTrans Slope (%)	2.4
No	Ramp Width (in)	47.5	No	BlendTrans XSlope (%)	2.4
N/A	Flare Type LT	N/A	N/A	Flare Type RT	N/A
N/A	Flare Slope LT (%)	N/A	N/A	Flare Slope RT (%)	N/A
N/A	Flare Traversable LT?	N/A	N/A	Flare Traversable RT?	N/A
N/A	Landing Length (in)	N/A	N/A	DWS Provided?	N/A
N/A	Landing Width (in)	N/A	N/A	DWS Contrast?	N/A
N/A	Landing Slope (%)	N/A	N/A	DWS Length (in)	N/A
N/A	Landing X Slope (%)	N/A	N/A	DWS Full Width?	N/A
N/A	Landing Curb? (Y/N)	N/A	N/A	DWS Offset (in)	N/A
N/A	Shared Landing?	N/A			
N/A	Gutter Ponding?	N/A	N/A	Gutter Slope (%)	N/A
N/A	Gutter Lip Ht (in)	N/A	N/A	Gutter X Slope (%)	N/A
N/A	Painted X Walk1?	No	N/A	Painted X Walk2?	N/A
	X Walk 1 Direction	To NE		X Walk 2 Direction	N/A
	X Walk 1 Width (in)	N/A		X Walk 2 Width (in)	N/A
	X Walk 1 Slope (%)	6.3		X Walk 2 Slope (%)	N/A
	X Walk 1 X Slope (%)	3.3		X Walk 2 X Slope (%)	N/A

N/A	Ramp inside XWalk1?	N/A	N/A	Ramp inside XWalk2?	N/A
	Road Slope (%)	3.3		Clear Space?	N/A
	Road X Slope (%)	6.3	N/A	Clear Space to XWalk (in)	N/A
N/A	Any Obstructions?	N/A	N/A	Storm Grate/Utility Hazard?	N/A
	Obstruction Type			Storm Grate/Utility Type	
		N/A			N/A
			Yes	Surface Condition? (G/P)	Good
			No	Curb Slope (%)	17.5

Remove & Replace Curb Ramp With Two New Directional Ramps or Equivalent.

Total Cost: \$ 3200.00
