# Access Compliance Report

## Public Rights-of-Way

### (Curb Ramps)

Intersection ID: 18132	Main Street: BRANDYWINE_RD	Cross Street: HASSELL_PL	Location: SW
ADA ID: 5A436086DC2F	Ramp Type: PerpDiag	Initial Pass/Fail: Fail	Overall Compliance: No
Severity Score: 72.5			
Codes/Mitigation Info/Possible Solution		Field Measurements/Component Compliance

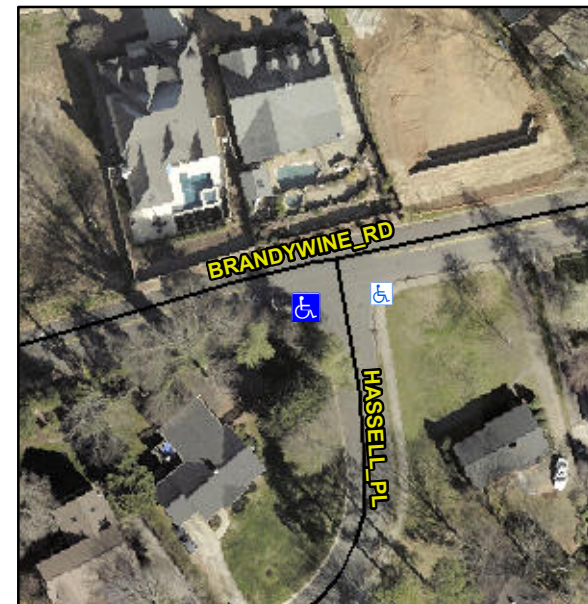
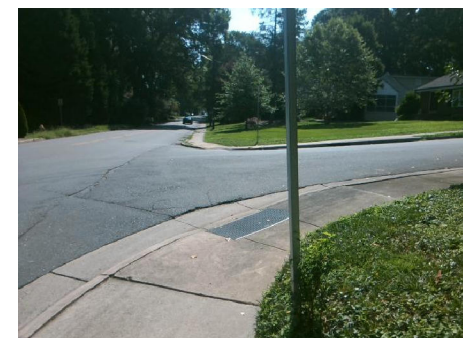
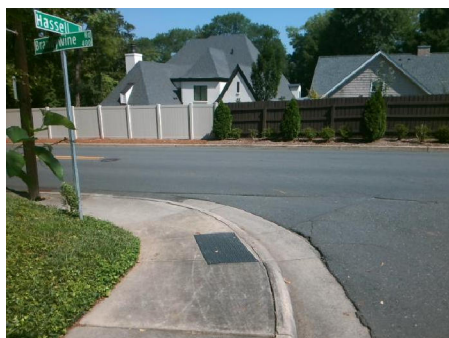
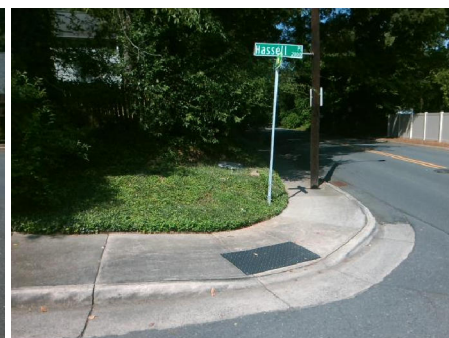
**R304.5.1, R304.2.2, R304.5.3**

Compliance	Description	Data	Compliance	Description	Data
N/A	Ramp Length (in)	58.0	No	Ramp Slope (%)	9.1
No	Ramp Width (in)	30.0	No	Ramp XSlope (%)	14.8
N/A	Flare Type LT	N/A	N/A	Flare Type RT	N/A
N/A	Flare Slope LT (%)	N/A	N/A	Flare Slope RT (%)	N/A
N/A	Flare Traversable LT?	N/A	N/A	Flare Traversable RT?	N/A
N/A	Landing Length (in)	N/A	N/A	DWS Provided?	N/A
N/A	Landing Width (in)	N/A	N/A	DWS Contrast?	N/A
N/A	Landing Slope (%)	N/A	N/A	DWS Length (in)	N/A
N/A	Landing X Slope (%)	N/A	N/A	DWS Full Width?	N/A
N/A	Landing Curb? (Y/N)	N/A	N/A	DWS Offset (in)	N/A
N/A	Shared Landing?	N/A			
N/A	Gutter Ponding?	N/A	N/A	Gutter Slope (%)	N/A
N/A	Gutter Lip Ht (in)	N/A	N/A	Gutter X Slope (%)	N/A
N/A	Painted X Walk1?	No	N/A	Painted X Walk2?	No
	X Walk 1 Direction	To E		X Walk 2 Direction	To N
N/A	X Walk 1 Width (in)	N/A	N/A	X Walk 2 Width (in)	N/A
	X Walk 1 Slope (%)	10.6		X Walk 2 Slope (%)	3.8
	X Walk 1 X Slope (%)	3.9		X Walk 2 X Slope (%)	14.5

N/A	Ramp inside XWalk1?	N/A	N/A	Ramp inside XWalk2?	N/A
	Road Slope (%)	7.7	N/A	Clear Space?	N/A
	Road X Slope (%)	8.1	N/A	Clear Space to XWalk (in)	N/A
N/A	Any Obstructions?	N/A	N/A	Storm Grate/Utility Hazard?	N/A
	Obstruction Type			Storm Grate/Utility Type	
		N/A			N/A
			Yes	Surface Condition? (G/P)	Good

**Remove & Replace Curb Ramp With Two New Directional Ramps or Equivalent.**
