Access Compliance Report

Public Rights-of-Way

(Curb Ramps)

Intersection ID: 5879	Main Street: NEVIN_RD	Cross Street: ZION_RENAISSANCE_LN	Location: NW
ADA ID: 5A563C73CB80	Ramp Type: Perp	Initial Pass/Fail: Pass	Overall Compliance: No
		Severity Score: 10

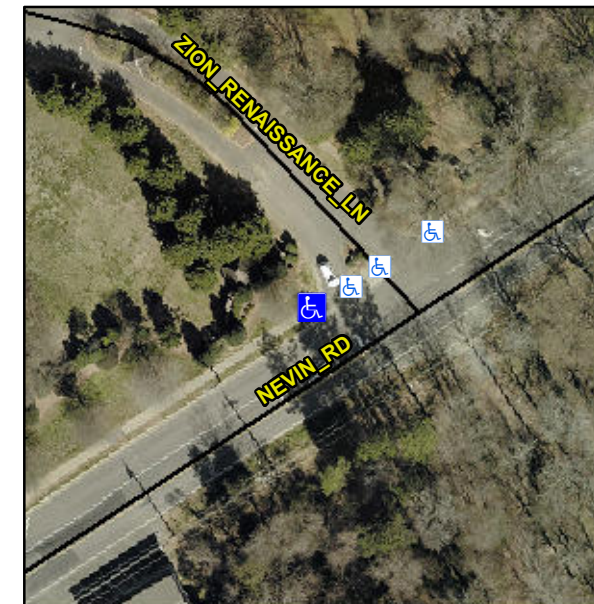
Not Found, R304.2.1, R304.2.2-Perp, R304.3.2-Para, R304.5.3, R305.2

Compliance	Description	Data	Compliance	Description	Data
N/A	Ramp Length (in)	95.0	Yes	Ramp Slope (%)	5.1
Yes	Ramp Width (in)	49.0	Yes	Ramp XSlope (%)	1.7
N/A	Flare Type LT	Sloped	N/A	Flare Type RT	N/A
N/A	Flare Slope LT (%)	2.6	N/A	Flare Slope RT (%)	5.5
N/A	Flare Traversable LT?	Yes	N/A	Flare Traversable RT?	No
No	Landing Length (in)	N/A	Yes	DWS Provided?	Yes
No	Landing Width (in)	N/A	Yes	DWS Contrast?	Yes
No	Landing Slope (%)	N/A	Yes	DWS Length (in)	25.5
No	Landing X Slope (%)	N/A	Yes	DWS Full Width?	Yes
N/A	Landing Curb? (Y/N)	No	No	DWS Offset (in)	2.5
N/A	Shared Landing?	No			
Yes	Gutter Ponding?	No	Yes	Gutter Slope (%)	1.4
Yes	Gutter Lip Ht (in)	0.0	Yes	Gutter X Slope (%)	1.9
N/A	Painted X Walk1?	No	N/A	Painted X Walk2?	N/A
	X Walk 1 Direction	To NE		X Walk 2 Direction	N/A
N/A	X Walk 1 Width (in)	N/A	N/A	X Walk 2 Width (in)	N/A
	X Walk 1 Slope (%)	0.6		X Walk 2 Slope (%)	N/A
	X Walk 1 X Slope (%)	1.2		X Walk 2 X Slope (%)	N/A

N/A	Ramp inside XWalk1?	N/A	N/A	Ramp inside XWalk2?	N/A
	Road Slope (%)	N/A	N/A	Clear Space?	Yes
	Road X Slope (%)	N/A	N/A	Clear Space to XWalk (in)	N/A
Yes	Any Obstructions?	No	Yes	Storm Grate/Utility Hazard?	No
	Obstruction Type			Storm Grate/Utility Type	
		N/A			N/A
			Yes	Surface Condition? (G/P)	Good

Remove & Replace Entire Ramp.
