# Access Compliance Report

## Public Rights-of-Way

### (Curb Ramps)

Intersection ID: 10037212	Main Street: SANDY_ROCK_PL	Cross Street: N/A	Location: W
ADA ID: 5A60012F76B5	Ramp Type: Perp	Initial Pass/Fail: Pass	Overall Compliance: No
			Severity Score: 5
Codes/Mitigation Info/Possible Solution		Field Measurements/Component Compliance

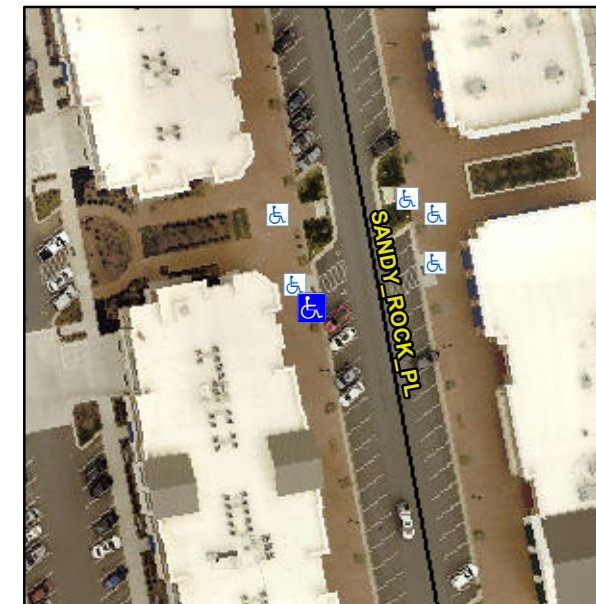
**Not Found, R304.5.4**

Compliance	Description	Data	Compliance	Description	Data
N/A	Ramp Length (in)	84.0	Yes	Ramp Slope (%)	6.7
Yes	Ramp Width (in)	59.0	Yes	Ramp XSlope (%)	1.2
N/A	Flare Type LT	Sloped	N/A	Flare Type RT	N/A
N/A	Flare Slope LT (%)	6.8	Yes	Flare Slope RT (%)	8.0
N/A	Flare Traversable LT?	Yes	N/A	Flare Traversable RT?	Yes
Yes	Landing Length (in)	60.0	Yes	DWS Provided?	Yes
Yes	Landing Width (in)	60.0	Yes	DWS Contrast?	Yes
Yes	Landing Slope (%)	0.5	Yes	DWS Length (in)	24.0
Yes	Landing X Slope (%)	1.5	Yes	DWS Full Width?	Yes
N/A	Landing Curb? (Y/N)	No	Yes	DWS Offset (in)	0.0
N/A	Shared Landing?	No			
Yes	Gutter Ponding?	No	No	Gutter Slope (%)	7.2
Yes	Gutter Lip Ht (in)	0.0	Yes	Gutter X Slope (%)	1.3
N/A	Painted X Walk1?	No	N/A	Painted X Walk2?	N/A
	X Walk 1 Direction	To E		X Walk 2 Direction	N/A
N/A	X Walk 1 Width (in)	N/A	N/A	X Walk 2 Width (in)	N/A
	X Walk 1 Slope (%)	2.5		X Walk 2 Slope (%)	N/A
	X Walk 1 X Slope (%)	1.4		X Walk 2 X Slope (%)	N/A

N/A	Ramp inside XWalk1?	N/A	N/A	Ramp inside XWalk2?	N/A
	Road Slope (%)	N/A	N/A	Clear Space?	Yes
	Road X Slope (%)	N/A	N/A	Clear Space to XWalk (in)	N/A
Yes	Any Obstructions?	No	Yes	Storm Grate/Utility Hazard?	No
	Obstruction Type			Storm Grate/Utility Type	
		N/A			N/A
			Yes	Surface Condition? (G/P)	Good

**Remove & Replace Entire Ramp.  
Remove & Replace Gutter.**
