Access Compliance Report

Public Rights-of-Way

(Curb Ramps)

Intersection ID: 19146	Main Street: TYVOLA_RD	Cross Street: WEDGEWOOD_DR	Location: NW
ADA ID: 5A642621D820	Ramp Type: PerpDiag	Initial Pass/Fail: Fail	Overall Compliance: No
		Severity Score: 12.5

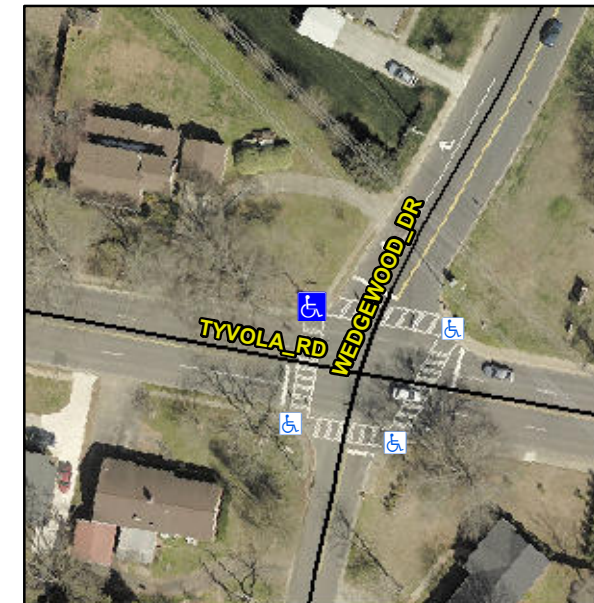
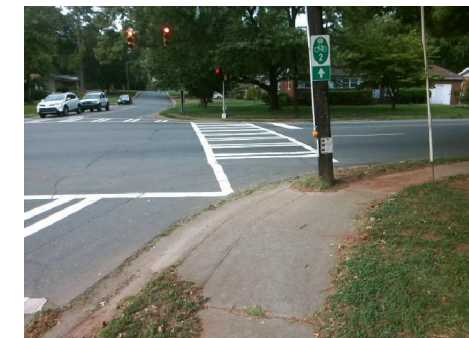
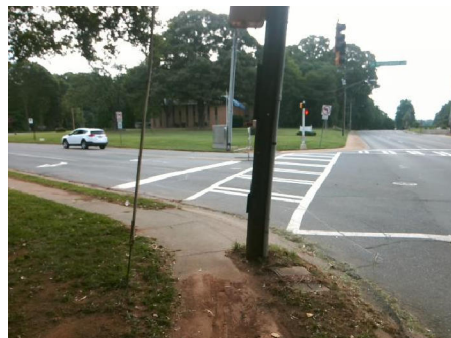
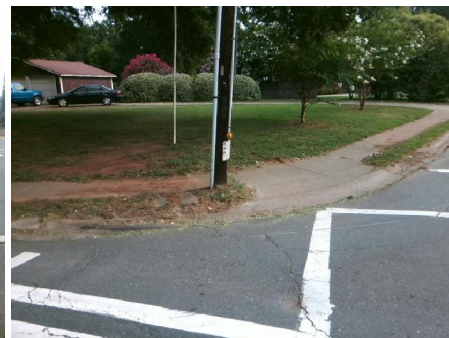
Compliance	Description	Data	Compliance	Description	Data
N/A	Ramp Length (in)	34.5	No	Ramp Slope (%)	10.5
Yes	Ramp Width (in)	96.0	Yes	Ramp XSlope (%)	0.7
N/A	Flare Type LT	N/A	N/A	Flare Type RT	N/A
N/A	Flare Slope LT (%)	N/A	N/A	Flare Slope RT (%)	N/A
N/A	Flare Traversable LT?	N/A	N/A	Flare Traversable RT?	N/A
N/A	Landing Length (in)	N/A	N/A	DWS Provided?	N/A
N/A	Landing Width (in)	N/A	N/A	DWS Contrast?	N/A
N/A	Landing Slope (%)	N/A	N/A	DWS Length (in)	N/A
N/A	Landing X Slope (%)	N/A	N/A	DWS Full Width?	N/A
N/A	Landing Curb? (Y/N)	N/A	N/A	DWS Offset (in)	N/A
N/A	Shared Landing?	N/A			
N/A	Gutter Ponding?	N/A	N/A	Gutter Slope (%)	N/A
N/A	Gutter Lip Ht (in)	N/A	N/A	Gutter X Slope (%)	N/A
N/A	Painted X Walk1?	Yes	N/A	Painted X Walk2?	Yes
	X Walk 1 Direction	To SW		X Walk 2 Direction	To SE
N/A	X Walk 1 Width (in)	107.0	N/A	X Walk 2 Width (in)	108.0
	X Walk 1 Slope (%)	6.2		X Walk 2 Slope (%)	5.6
	X Walk 1 X Slope (%)	2.8		X Walk 2 X Slope (%)	3.1

N/A	Ramp inside XWalk1?	No	N/A	Ramp inside XWalk2?	Yes
	Road Slope (%)	1.0	N/A	Clear Space?	N/A
	Road X Slope (%)	5.2	N/A	Clear Space to XWalk (in)	N/A
N/A	Any Obstructions?	N/A	N/A	Storm Grate/Utility Hazard?	N/A
	Obstruction Type			Storm Grate/Utility Type	
		N/A			N/A
			Yes	Surface Condition? (G/P)	Good

Remove & Replace Curb Ramp With Two New Directional Ramps or Equivalent. Restripe Crosswalk.
