Access Compliance Report

Public Rights-of-Way

(Curb Ramps)

Intersection ID: 15242	Main Street: E_INDEPENDENCE_BV	Cross Street: N_WENDOVER_RD_RA	Location: SE
ADA ID: 5A643CC2BC90	Ramp Type: Perp	Initial Pass/Fail: Fail	Overall Compliance: No
			Severity Score: 21.25

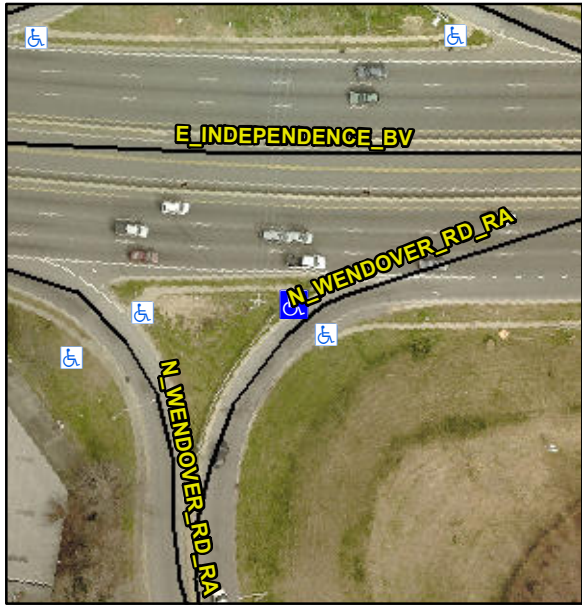
Possible Solutions:		Compliance	Description	Data	Compliance	Description	Data
	Remove & Replace Entire Ramp.		N/A	Ramp Length (in)	62.0	No	Ramp Slope (%)	9.0
			No	Ramp Width (in)	41.0	Yes	Ramp XSlope (%)	0.1
			N/A	Flare Type LT	N/A	N/A	Flare Type RT	N/A
			N/A	Flare Slope LT (%)	N/A	N/A	Flare Slope RT (%)	N/A
			N/A	Flare Traversable LT?	N/A	N/A	Flare Traversable RT?	N/A
			N/A	Landing Length (in)	N/A	N/A	DWS Provided?	N/A
			N/A	Landing Width (in)	N/A	N/A	DWS Contrast?	N/A
			N/A	Landing Slope (%)	N/A	N/A	DWS Length (in)	N/A
			N/A	Landing X Slope (%)	N/A	N/A	DWS Full Width?	N/A
Surveyor Notes:		N/A	N/A	Landing Curb? (Y/N)	N/A	N/A	DWS Offset (in)	N/A
PROW/ADA:		Not Found, R304.5.1, R304.2.2		N/A	Shared Landing?	N/A		
			N/A	Gutter Ponding?	N/A	N/A	Gutter Slope (%)	N/A
			N/A	Gutter Lip Ht (in)	N/A	N/A	Gutter X Slope (%)	N/A

N/A	Painted X Walk1?	No	N/A	Painted X Walk2?	N/A
				X Walk 1 Direction	To S		X Walk 2 Direction	N/A
			N/A	X Walk 1 Width (in)	N/A	N/A	X Walk 2 Width (in)	N/A
				X Walk 1 Slope (%)	7.8		X Walk 2 Slope (%)	N/A
				X Walk 1 X Slope (%)	0.9		X Walk 2 X Slope (%)	N/A
			N/A	Ramp inside XWalk1?	N/A	N/A	Ramp inside XWalk2?	N/A
				Road Slope (%)	N/A	N/A	Clear Space?	N/A
				Road X Slope (%)	N/A	N/A	Clear Space to XWalk (in)	N/A
			N/A	Any Obstructions?	N/A	N/A	Storm Grate/Utility Hazard?	N/A
				Obstruction Type			Storm Grate/Utility Type	
						N/A		N/A
						Yes	Surface Condition? (G/P)	Good
