Access Compliance Report

Public Rights-of-Way

(Curb Ramps)

Intersection ID: 30034	Main Street: DAY_LILLY_LN	Cross Street: SUMMER_COACH_DR	Location: W
ADA ID: 5A6548DFE2DF	Ramp Type: Perp	Initial Pass/Fail: Pass	Overall Compliance: No
Severity Score: 10			
Codes/Mitigation Info/Possible Solution		Field Measurements/Component Compliance

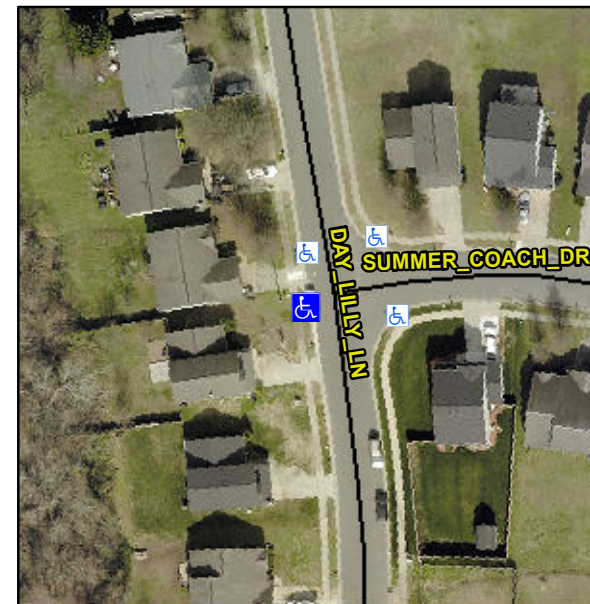
Compliance	Description	Data	Compliance	Description	Data
N/A	Ramp Length (in)	45.5	Yes	Ramp Slope (%)	8.2
Yes	Ramp Width (in)	48.0	Yes	Ramp XSlope (%)	1.7
N/A	Flare Type LT	Sloped	N/A	Flare Type RT	N/A
N/A	Flare Slope LT (%)	10.3	Yes	Flare Slope RT (%)	9.9
N/A	Flare Traversable LT?	Yes	N/A	Flare Traversable RT?	Yes
Yes	Landing Length (in)	48.0	Yes	DWS Provided?	Yes
Yes	Landing Width (in)	48.0	Yes	DWS Contrast?	Yes
No	Landing Slope (%)	3.0	Yes	DWS Length (in)	25.5
Yes	Landing X Slope (%)	0.5	Yes	DWS Full Width?	Yes
N/A	Landing Curb? (Y/N)	No	No	DWS Offset (in)	3.0
N/A	Shared Landing?	No			
Yes	Gutter Ponding?	No	Yes	Gutter Slope (%)	3.4
No	Gutter Lip Ht (in)	0.5	Yes	Gutter X Slope (%)	0.9
N/A	Painted X Walk1?	No	N/A	Painted X Walk2?	N/A
	X Walk 1 Direction	To NE		X Walk 2 Direction	N/A
N/A	X Walk 1 Width (in)	N/A	N/A	X Walk 2 Width (in)	N/A
	X Walk 1 Slope (%)	1.4		X Walk 2 Slope (%)	N/A
	X Walk 1 X Slope (%)	0.5		X Walk 2 X Slope (%)	N/A

N/A	Ramp inside XWalk1?	N/A	N/A	Ramp inside XWalk2?	N/A
	Road Slope (%)	N/A	N/A	Clear Space?	Yes
	Road X Slope (%)	N/A	N/A	Clear Space to XWalk (in)	N/A
Yes	Any Obstructions?	No	Yes	Storm Grate/Utility Hazard?	No
	Obstruction Type			Storm Grate/Utility Type	
		N/A			N/A
			Yes	Surface Condition? (G/P)	Good

**Remove & Replace Entire Ramp.
Grind Gutter Lip.**
