Access Compliance Report

Public Rights-of-Way

(Curb Ramps)

Intersection ID: 48581	Main Street: WATERLILY_LN	Cross Street: RUMPLE_RD	Location: NW
ADA ID: 5A6C5DE69FF9	Ramp Type: BlendTrans1	Initial Pass/Fail: Fail	Overall Compliance: No
Codes/Mitigation Info/Possible Solution		Field Measurements/Component Compliance	
Severity Score: 8.75

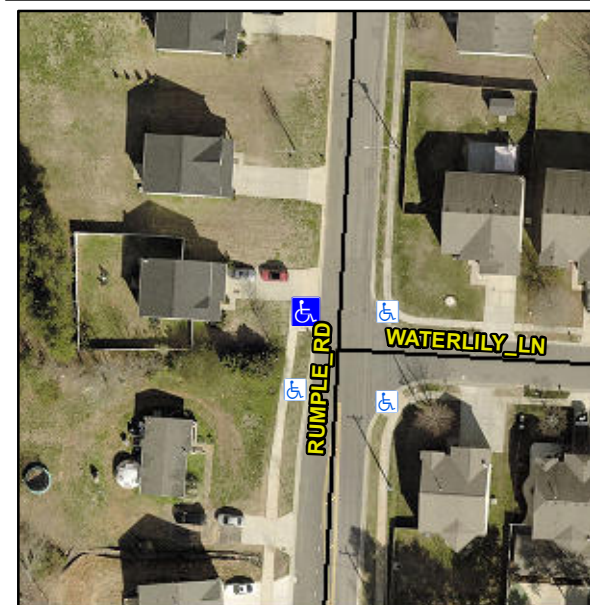
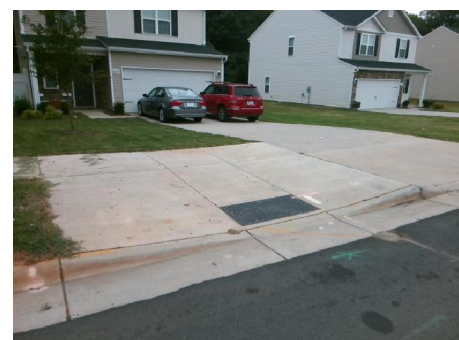
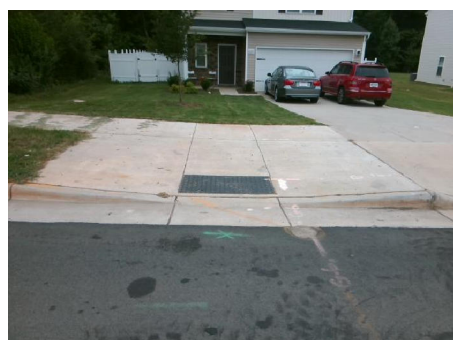
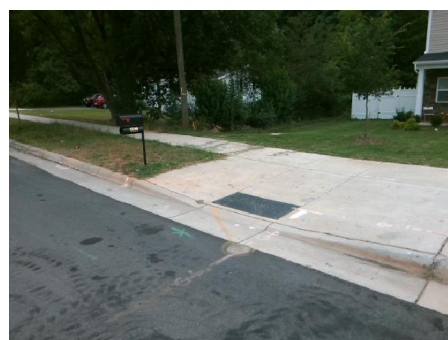
Not Found, R304.5.1

Compliance	Description	Data	Compliance	Description	Data
N/A	Ramp Length (in)	98.0	Yes	BlendTrans Slope (%)	4.7
No	Ramp Width (in)	47.5	Yes	BlendTrans XSlope (%)	1.1
N/A	Flare Type LT	N/A	N/A	Flare Type RT	N/A
N/A	Flare Slope LT (%)	N/A	N/A	Flare Slope RT (%)	N/A
N/A	Flare Traversable LT?	N/A	N/A	Flare Traversable RT?	N/A
N/A	Landing Length (in)	N/A	N/A	DWS Provided?	N/A
N/A	Landing Width (in)	N/A	N/A	DWS Contrast?	N/A
N/A	Landing Slope (%)	N/A	N/A	DWS Length (in)	N/A
N/A	Landing X Slope (%)	N/A	N/A	DWS Full Width?	N/A
N/A	Landing Curb? (Y/N)	N/A	N/A	DWS Offset (in)	N/A
N/A	Shared Landing?	N/A			
N/A	Gutter Ponding?	N/A	N/A	Gutter Slope (%)	N/A
N/A	Gutter Lip Ht (in)	1.0	N/A	Gutter X Slope (%)	N/A
N/A	Painted X Walk1?	No	N/A	Painted X Walk2?	N/A
	X Walk 1 Direction	To E		X Walk 2 Direction	N/A
	X Walk 1 Width (in)	N/A		X Walk 2 Width (in)	N/A
	X Walk 1 Slope (%)	1.2		X Walk 2 Slope (%)	N/A
	X Walk 1 X Slope (%)	1.9		X Walk 2 X Slope (%)	N/A

N/A	Ramp inside XWalk1?	N/A	N/A	Ramp inside XWalk2?	N/A
	Road Slope (%)	1.9		Clear Space?	N/A
	Road X Slope (%)	1.2	N/A	Clear Space to XWalk (in)	N/A
N/A	Any Obstructions?	N/A	N/A	Storm Grate/Utility Hazard?	N/A
	Obstruction Type			Storm Grate/Utility Type	
		N/A			N/A
			Yes	Surface Condition? (G/P)	Good
			No	Curb Slope (%)	17.9

Remove & Replace Curb Ramp With Two New Directional Ramps or Equivalent.
