# Access Compliance Report

## Public Rights-of-Way

### (Curb Ramps)

Intersection ID: 29231	Main Street: KORNIV_DR	Cross Street: COPPALA_DR	Location: SW
ADA ID: 5A6D71FE0582	Ramp Type: BlendTrans2	Initial Pass/Fail: Pass	Overall Compliance: No
Severity Score: 22.75			
Codes/Mitigation Info/Possible Solution		Field Measurements/Component Compliance

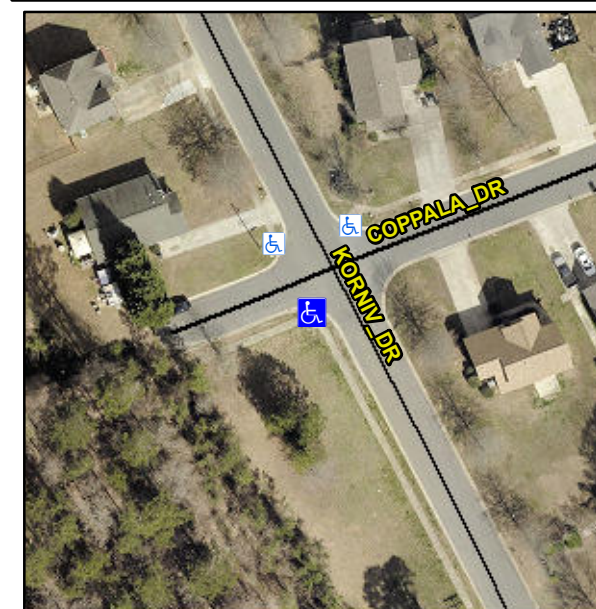
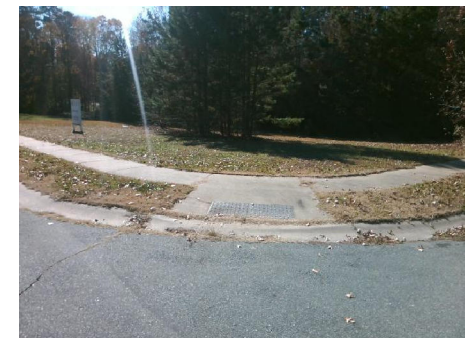
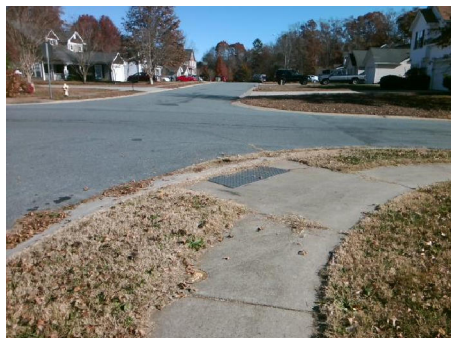
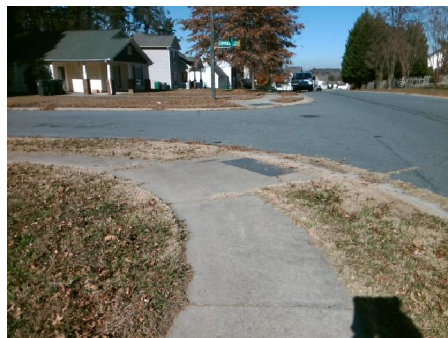
**Not Found, R305.1.4, R305.2, R302.7.2, R304.5.4**

Compliance	Description	Data	Compliance	Description	Data
N/A	Ramp Length (in)	97.0	Yes	BlendTrans Slope (%)	3.5
Yes	Ramp Width (in)	48.0	Yes	BlendTrans XSlope (%)	2.1
N/A	Flare Type LT	Sloped	N/A	Flare Type RT	Sloped
N/A	Flare Slope LT (%)	5.4	N/A	Flare Slope RT (%)	0.6
N/A	Flare Traversable LT?	No	N/A	Flare Traversable RT?	No
N/A	Landing Length (in)	N/A	Yes	DWS Provided?	Yes
N/A	Landing Width (in)	N/A	Yes	DWS Contrast?	Yes
N/A	Landing Slope (%)	N/A	Yes	DWS Length (in)	24.0
N/A	Landing X Slope (%)	N/A	No	DWS Full Width?	No
N/A	Landing Curb? (Y/N)	No	No	DWS Offset (in)	5.0
N/A	Shared Landing?	No			
Yes	Gutter Ponding?	No	No	Gutter Slope (%)	6.6
No	Gutter Lip Ht (in)	1.0	Yes	Gutter X Slope (%)	1.3
N/A	Painted X Walk1?	No	N/A	Painted X Walk2?	N/A
	X Walk 1 Direction	To NW		X Walk 2 Direction	N/A
	X Walk 1 Width (in)	N/A		X Walk 2 Width (in)	N/A
	X Walk 1 Slope (%)	2.4		X Walk 2 Slope (%)	N/A
	X Walk 1 X Slope (%)	4.2		X Walk 2 X Slope (%)	N/A

N/A	Ramp inside XWalk1?	N/A	N/A	Ramp inside XWalk2?	N/A
	Road Slope (%)	4.2		Clear Space?	Yes
	Road X Slope (%)	2.4	N/A	Clear Space to XWalk (in)	N/A
Yes	Any Obstructions?	No	Yes	Storm Grate/Utility Hazard?	No
	Obstruction Type			Storm Grate/Utility Type	
		N/A			N/A
			Yes	Surface Condition? (G/P)	Good
			No	Curb Slope (%)	19.1

**Remove & Replace Curb Ramp With Two New Directional Ramps or Equivalent. Remove & Replace Gutter.**

Total Cost: \$ **3950.00**
