# Access Compliance Report

## Public Rights-of-Way

| Intersection ID: 30314 | Main Street: ROCKET_LN | Cross Street: SHINKANSEN_DR | Location: N |
| ADA ID: 5A6E2A403ED5 | Ramp Type: BlendTrans1 | Initial Pass/Fail: Fail | Overall Compliance: No |

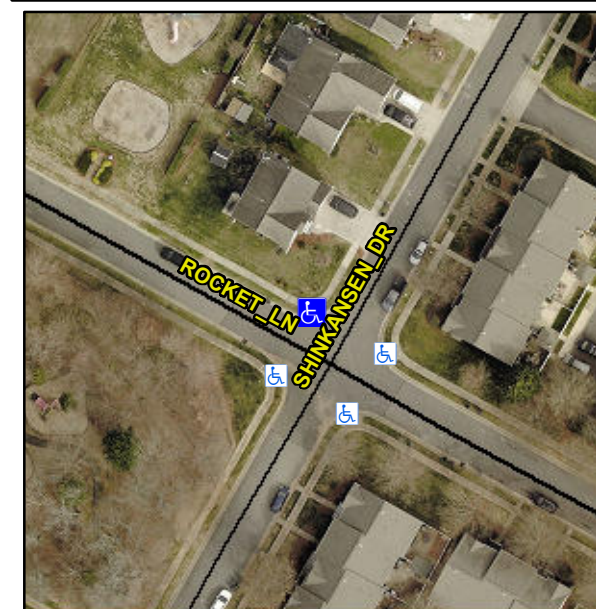
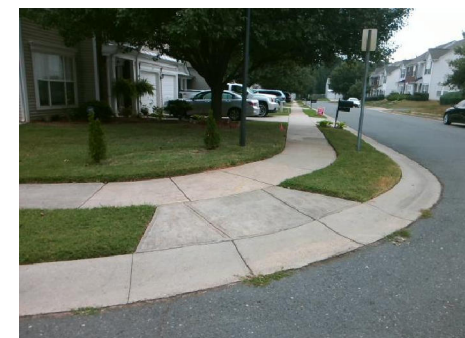
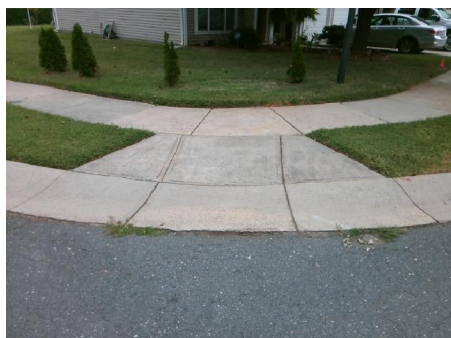
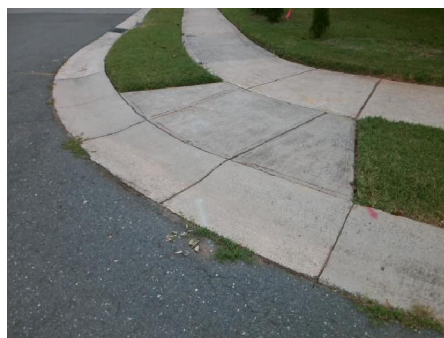
| Severity Score: 10 | | | |

**Not Found, R304.5.1, R304.5.3**

| Compliance | Description | Data | Compliance | Description | Data |
|---|---|---|---|---|---|
| No | Ramp Width (in) | 41.5 | No | BlendTrans XSlope (%) | 4.2 |
| | | | No | Curb Slope (%) | 19.2 |

**Remove & Replace Curb Ramp With Two New Directional Ramps or Equivalent.**

Total Cost: \$ 3200.00
