# Access Compliance Report

## Public Rights-of-Way

### (Curb Ramps)

Intersection ID: 7805	Main Street: HIDDEN_VALLEY_RD	Cross Street: WHITE_PLAINS_RD	Location:	E
ADA ID: 5A780BDF9F90	Ramp Type: Combination1	Initial Pass/Fail: Fail	Overall Compliance: No	Severity Score: 8.75
Codes/Mitigation Info/Possible Solution		Field Measurements/Component Compliance

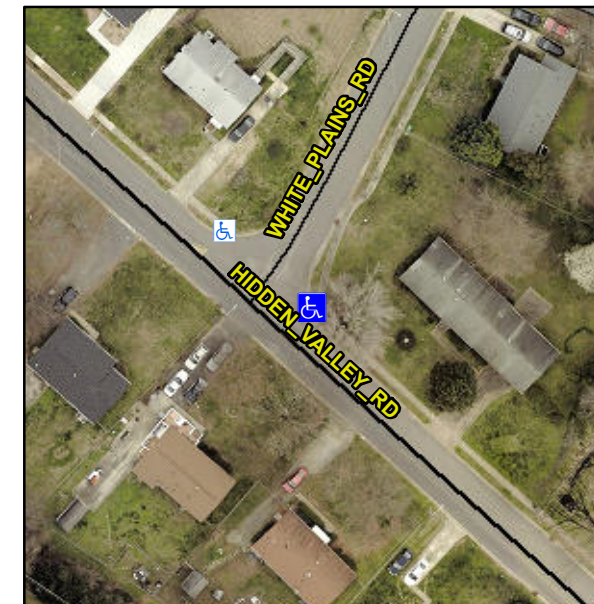
**GTR LIP 2.0, RT RP < 5%**

**Not Found, R304.5.1, R304.5.1**

Compliance	Description	Data	Compliance	Description	Data
N/A	Ramp Length LT (in)	19.0	N/A	Ramp Length RT (in)	21.5
No	Ramp Width LT (in)	47.0	Yes	Ramp Width RT (in)	48.0
Yes	Ramp Slope LT (%)	7.0	Yes	Ramp Slope RT (%)	1.0
Yes	Ramp XSlope LT (%)	1.1	Yes	Ramp XSlope RT (%)	1.1
N/A	Ramp Length (in)	33.5	Yes	Ramp Slope (%)	7.0
No	Ramp Width (in)	38.0	Yes	Ramp XSlope (%)	1.3
N/A	Flare Type LT	N/A	N/A	Flare Type RT	N/A
N/A	Flare Slope LT (%)	N/A	N/A	Flare Slope RT (%)	N/A
N/A	Flare Traversable LT?	N/A	N/A	Flare Traversable RT?	N/A
N/A	Landing Length (in)	N/A	N/A	DWS Provided?	N/A
N/A	Landing Width (in)	N/A	N/A	DWS Contrast?	N/A
N/A	Landing Slope (%)	N/A	N/A	DWS Length (in)	N/A
N/A	Landing X Slope (%)	N/A	N/A	DWS Full Width?	N/A
N/A	Landing Curb? (Y/N)	N/A	N/A	DWS Offset (in)	N/A
N/A	Shared Landing?	N/A			
N/A	Gutter Ponding?	N/A	N/A	Gutter Slope (%)	N/A
N/A	Gutter Lip Ht (in)	N/A	N/A	Gutter X Slope (%)	N/A
N/A	Painted X Walk1?	No	N/A	Painted X Walk2?	N/A

X Walk 1 Direction	To NW		X Walk 2 Direction	N/A
	X Walk 1 Width (in)	N/A		X Walk 2 Width (in)	N/A
	X Walk 1 Slope (%)	5.5		X Walk 2 Slope (%)	N/A
	X Walk 1 X Slope (%)	3.0		X Walk 2 X Slope (%)	N/A
N/A	Ramp inside XWalk1?	N/A	N/A	Ramp inside XWalk2?	N/A
	Road Slope (%)	N/A		Clear Space?	N/A
	Road X Slope (%)	N/A	N/A	Clear Space to XWalk (in)	N/A
			N/A	Any Obstruction?	N/A
				Obstruction Type	N/A
			N/A	Storm Grate/Utility Hazard?	N/A
				Storm Grate/Utility Type	N/A
			Yes	Surface Condition? (G/P)	Good
				Curb Slope (%)	15.0

Possible Solutions:

**Remove & Replace Entire Ramp.**

Total Cost: \$ 1800.00
