# Access Compliance Report

## Public Rights-of-Way

### (Curb Ramps)

Intersection ID: 9052	Main Street: JEFFERSON_DAVIS_ST	Cross Street: MORETZ_AV	Location: S
ADA ID: 5A78647A4B5E	Ramp Type: Para	Initial Pass/Fail: Fail	Overall Compliance: No
Codes/Mitigation Info/Possible Solution		Field Measurements/Component Compliance	
Severity Score: 36.25

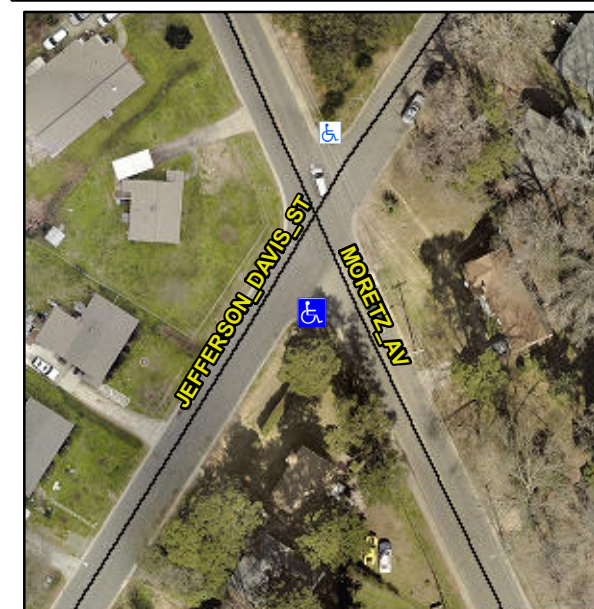
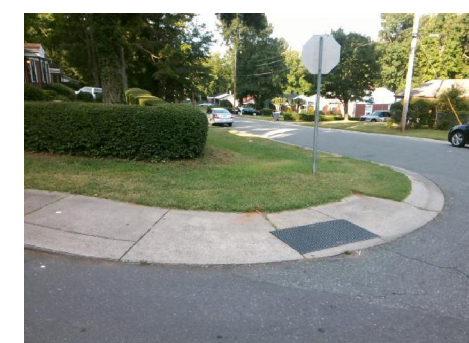
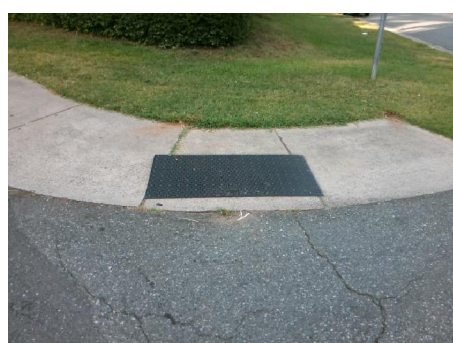
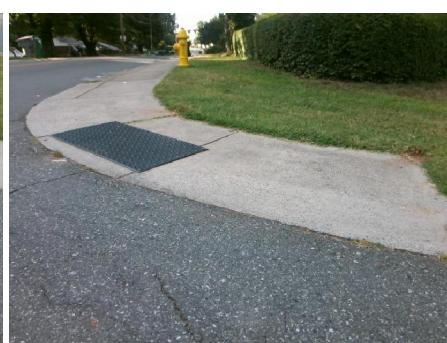
**RT RP < 5%, NO RT SW**

Compliance	Description	Data	Compliance	Description	Data
N/A	Ramp Length LT (in)	47.0	N/A	Ramp Length RT (in)	55.0
Yes	Ramp Width LT (in)	53.5	No	Ramp Width RT (in)	30.0
Yes	Ramp Slope LT (%)	6.7	Yes	Ramp Slope RT (%)	3.7
No	Ramp XSlope LT (%)	3.8	No	Ramp XSlope RT (%)	3.8
N/A	Landing Length (in)	N/A	N/A	DWS Provided?	N/A
N/A	Landing Width (in)	N/A	N/A	DWS Contrast?	N/A
N/A	Landing Slope (%)	N/A	N/A	DWS Length (in)	N/A
N/A	Landing X Slope (%)	N/A	N/A	DWS Full Width?	N/A
N/A	Landing Curb? (Y/N)	N/A	N/A	DWS Offset (in)	N/A
N/A	Shared Landing?	N/A			
N/A	Gutter Ponding?	N/A	N/A	Gutter Slope (%)	N/A
N/A	Gutter Lip Ht (in)	1.0	N/A	Gutter X Slope (%)	N/A
N/A	Painted X Walk1?	No	N/A	Painted X Walk2?	N/A
	X Walk 1 Direction	To N		X Walk 2 Direction	N/A
N/A	X Walk 1 Width (in)	N/A	N/A	X Walk 2 Width (in)	N/A
	X Walk 1 Slope (%)	5.1		X Walk 2 Slope (%)	N/A
	X Walk 1 X Slope (%)	2.7		X Walk 2 X Slope (%)	N/A
N/A	Ramp inside XWalk1?	N/A	N/A	Ramp inside XWalk2?	N/A

Road Slope (%)	N/A	N/A	Clear Space?	N/A
	Road X Slope (%)	N/A	N/A	Clear Space to XWalk (in)	N/A
N/A	Any Obstructions?	N/A	N/A	Storm Grate/Utility Hazard?	N/A
	Obstruction Type			Storm Grate/Utility Type	
		N/A			N/A
			Yes	Surface Condition? (G/P)	Good
			N/A	Curb Slope (%)	N/A

**Remove & Replace Entire Ramp.**

**R304.5.1, R304.5.3**
