Access Compliance Report

Public Rights-of-Way

(Curb Ramps)

Intersection ID: 29983	Main Street: REAMES_RD	Cross Street: SILVER_GARDEN_LN	Location: SE
ADA ID: 5A7E14244D63	Ramp Type: Perp	Initial Pass/Fail: Fail	Overall Compliance: No
Severity Score: 21.25			
Codes/Mitigation Info/Possible Solution		Field Measurements/Component Compliance

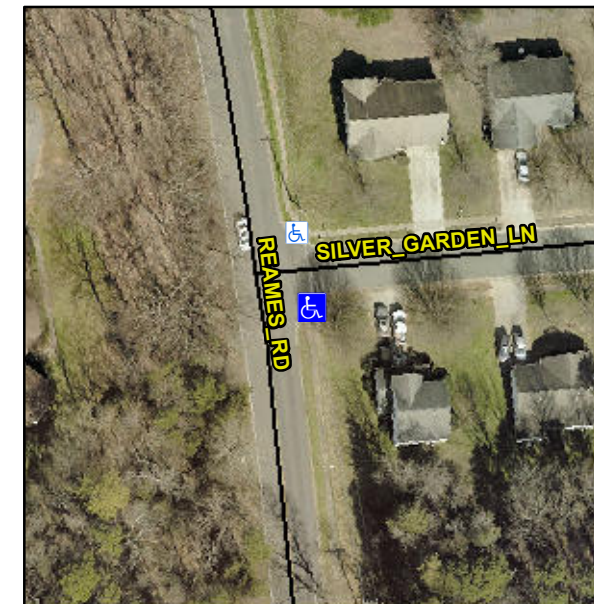
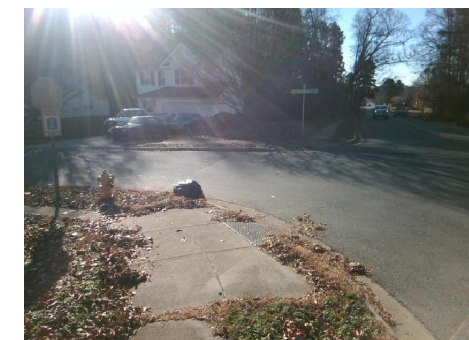
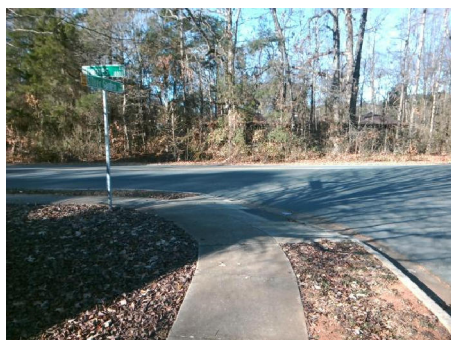
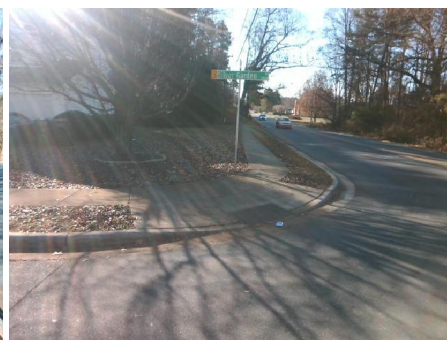
R304.5.1, R304.2.2

Compliance	Description	Data	Compliance	Description	Data
N/A	Ramp Length (in)	48.0	No	Ramp Slope (%)	11.5
No	Ramp Width (in)	47.3	Yes	Ramp XSlope (%)	0.6
N/A	Flare Type LT	N/A	N/A	Flare Type RT	N/A
N/A	Flare Slope LT (%)	N/A	N/A	Flare Slope RT (%)	N/A
N/A	Flare Traversable LT?	N/A	N/A	Flare Traversable RT?	N/A
N/A	Landing Length (in)	N/A	N/A	DWS Provided?	N/A
N/A	Landing Width (in)	N/A	N/A	DWS Contrast?	N/A
N/A	Landing Slope (%)	N/A	N/A	DWS Length (in)	N/A
N/A	Landing X Slope (%)	N/A	N/A	DWS Full Width?	N/A
N/A	Landing Curb? (Y/N)	N/A	N/A	DWS Offset (in)	N/A
N/A	Shared Landing?	N/A			
N/A	Gutter Ponding?	N/A	N/A	Gutter Slope (%)	N/A
N/A	Gutter Lip Ht (in)	N/A	N/A	Gutter X Slope (%)	N/A
N/A	Painted X Walk1?	No	N/A	Painted X Walk2?	N/A
	X Walk 1 Direction	To N		X Walk 2 Direction	N/A
N/A	X Walk 1 Width (in)	N/A	N/A	X Walk 2 Width (in)	N/A
	X Walk 1 Slope (%)	2.9		X Walk 2 Slope (%)	N/A
	X Walk 1 X Slope (%)	3.2		X Walk 2 X Slope (%)	N/A

N/A	Ramp inside XWalk1?	N/A	N/A	Ramp inside XWalk2?	N/A
	Road Slope (%)	N/A	N/A	Clear Space?	N/A
	Road X Slope (%)	N/A	N/A	Clear Space to XWalk (in)	N/A
N/A	Any Obstructions?	N/A	N/A	Storm Grate/Utility Hazard?	N/A
	Obstruction Type			Storm Grate/Utility Type	
		N/A			N/A
			Yes	Surface Condition? (G/P)	Good

Remove & Replace Entire Ramp.

Total Cost: \$ 1850.00
