Access Compliance Report Public Rights-of-Way (Curb Ramps)

Intersection ID: 28375 Main Street: CORNWALLIS_HALL_DR Cross Street: WHEATFIELD_RD Location: NW

ADA ID: 5A8812ADE7B4 Ramp Type: PerpDiag Initial Pass/Fail: Fail Overall Compliance: No Severity Score: 13.75

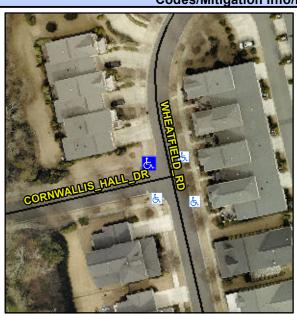
PROW/ADA:
Not Found, R304.2.2, R304.5.3

•	
Compliance Description		Data	Compli	iance Description	Data
N/A	Ramp Length (in)	71.0	No	Ramp Slope (%)	10.9
Yes	Ramp Width (in)	48.0	No	Ramp XSlope (%)	2.1
N/A	Flare Type LT	N/A	N/A	Flare Type RT	N/A
N/A	Flare Slope LT (%)	N/A	N/A	Flare Slope RT (%)	N/A
N/A	Flare Traversable LT?	N/A	N/A	Flare Traversable RT?	N/A
N/A	Landing Length (in)	N/A	N/A	DWS Provided?	N/A
N/A	Landing Width (in)	N/A	N/A	DWS Contrast?	N/A
N/A	Landing Slope (%)	N/A	N/A	DWS Length (in)	N/A
N/A	Landing X Slope (%)	N/A	N/A	DWS Full Width?	N/A
N/A	Landing Curb? (Y/N)	N/A	N/A	DWS Offset (in)	N/A
N/A	Shared Landing?	N/A			
N/A	Gutter Ponding?	N/A	N/A	Gutter Slope (%)	N/A
N/A	Gutter Lip Ht (in)	N/A	N/A	Gutter X Slope (%)	N/A
N/A	Painted X Walk1?	No	N/A	Painted X Walk2?	No
	X Walk 1 Direction	To S		X Walk 2 Direction	То Е
N/A	X Walk 1 Width (in)	N/A	N/A	X Walk 2 Width (in)	N/A
	X Walk 1 Slope (%)	1.9		X Walk 2 Slope (%)	3.2
	X Walk 1 X Slope (%)	2.2		X Walk 2 X Slope (%)	0.2

N/A	Ramp inside XWalk1?	N/A	N/A	Ramp inside XWalk2?	N/A
	Road Slope (%)	1.6	N/A	Clear Space?	N/A
	Road X Slope (%)	3.0	N/A	Clear Space to XWalk (in)	N/A
N/A	Any Obstructions?	N/A	N/A	Storm Grate/Utility Hazard?	N/A
	Obstruction Type		l	Storm Grate/Utility Type	
		N/A	l		N/A
			l

Remove & Replace Curb Ramp With
Two New Directional Ramps or
Equivalent.
