# Access Compliance Report

## Public Rights-of-Way

### (Curb Ramps)

Intersection ID: 10031812	Main Street: MILLENNIUM_AV	Cross Street: AUDUBON_PARK_DR	Location:	N
ADA ID: 5A89F3744BCD	Ramp Type: Directional1	Initial Pass/Fail: Fail	Overall Compliance: No	Severity Score: 12.5
Codes/Mitigation Info/Possible Solution		Field Measurements/Component Compliance

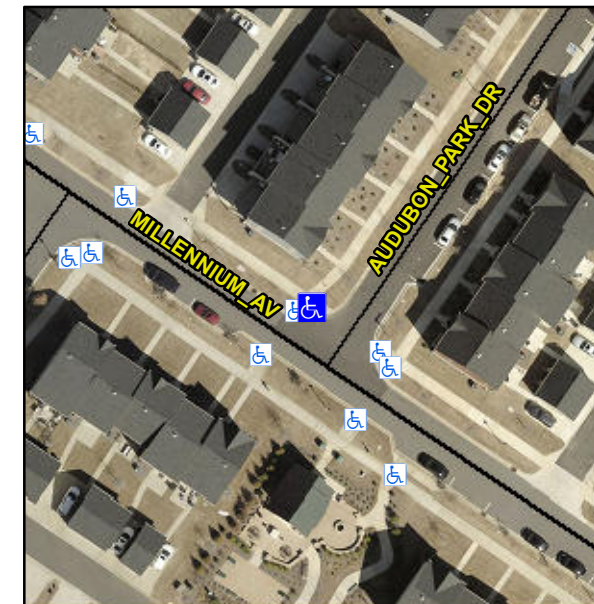
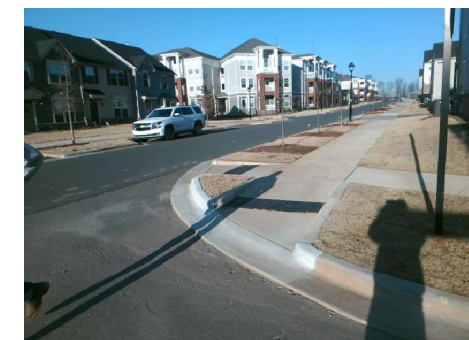
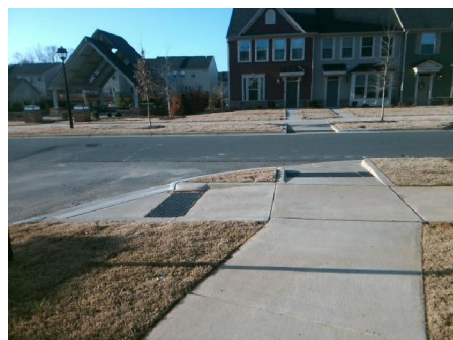
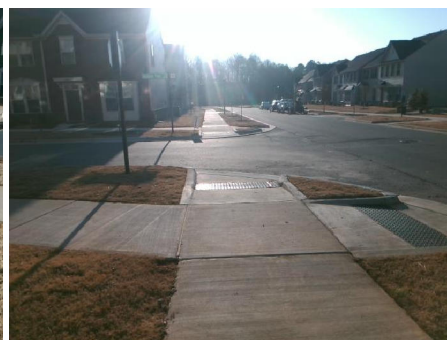
Compliance	Description	Data	Compliance	Description	Data
N/A	Ramp Length (in)	76.0	N/A	Grade Break?	N/A
Yes	Ramp Width (in)	69.0	N/A	Grade Break Slope (%)	0.0
No	Ramp Slope (%)	9.6	N/A	Grade Break XSlope (%)	0.0
Yes	Ramp XSlope (%)	0.1			
N/A	Flare Type LT	N/A	N/A	Flare Type RT	N/A
N/A	Flare Slope LT (%)	N/A	N/A	Flare Slope RT (%)	0.0
N/A	Flare Traversable LT?	N/A	N/A	Flare Traversable RT?	N/A
N/A	Landing Length (in)	0.0	N/A	DWS Provided?	N/A
N/A	Landing Width (in)	0.0	N/A	DWS Contrast?	N/A
N/A	Landing Slope (%)	0.0	N/A	DWS Length (in)	N/A
N/A	Landing X Slope (%)	0.0	N/A	DWS Full Width?	N/A
N/A	Landing Curb? (Y/N)	N/A	N/A	DWS Offset LT (in)	N/A
N/A	Shared Landing?	N/A	N/A	DWS Offset RT (in)	N/A
N/A	Gutter Ponding?	0.0	N/A	Gutter Slope (%)	N/A
N/A	Gutter Lip Ht (in)	0.0	N/A	Gutter X Slope (%)	N/A
N/A	Painted X Walk1?	No		Road Slope (%)	1.2
	X Walk 1 Direction	To SE		Road X Slope (%)	1.3
	X Walk 1 Width (in)	N/A		Clear Space?	N/A

X Walk 1 Slope (%)	1.2	N/A	Clear Space to XWalk (in)	N/A
	X Walk 1 X Slope (%)	1.3	N/A	Storm Grate/Utility Hazard?	N/A
N/A	Ramp inside XWalk1?	N/A		Storm Grate/Utility Type	
N/A	Any Obstructions?	N/A			N/A
	Obstruction Type		Yes	Surface Condition? (G/P)	Good
			N/A	Curb Slope (%)	3.3

**Remove & Replace Entire Ramp.**

**R304.2.2**

\$ 1600.00
