# Access Compliance Report

## Public Rights-of-Way

### (Curb Ramps)

Intersection ID: N/A	Main Street: FREEDOM_DR	Cross Street: S_I-85_RA	Location: W
ADA ID: 5A900AC13952	Ramp Type: BlendTrans1	Initial Pass/Fail: Pass	Overall Compliance: No
		Severity Score: 10

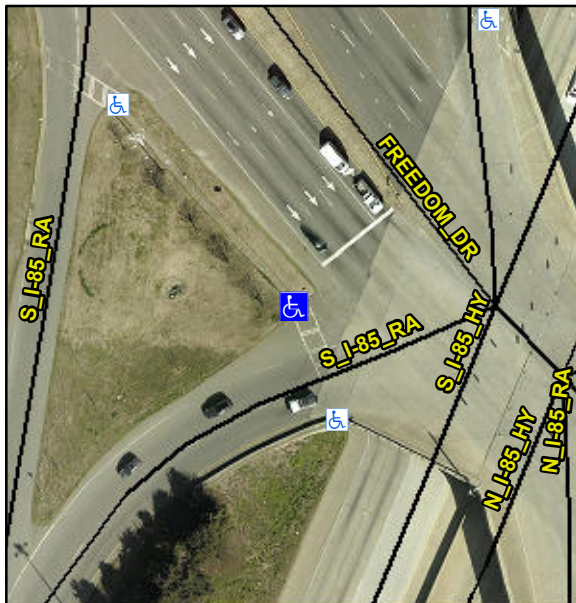
**LOCATED ON ISLAND**

Compliance	Description	Data	Compliance	Description	Data
N/A	Ramp Length (in)	60.0	Yes	BlendTrans Slope (%)	0.1
Yes	Ramp Width (in)	60.0	Yes	BlendTrans XSlope (%)	1.5
N/A	Flare Type LT	None	N/A	Flare Type RT	None
N/A	Flare Slope LT (%)	N/A	N/A	Flare Slope RT (%)	N/A
N/A	Flare Traversable LT?	N/A	N/A	Flare Traversable RT?	N/A
Yes	Landing Length (in)	60.0	No	DWS Provided?	No
Yes	Landing Width (in)	60.0	N/A	DWS Contrast?	No
Yes	Landing Slope (%)	0.0	N/A	DWS Length (in)	N/A
No	Landing X Slope (%)	2.3	N/A	DWS Full Width?	No
N/A	Landing Curb? (Y/N)	No	N/A	DWS Offset (in)	N/A
N/A	Shared Landing?	No			
Yes	Gutter Ponding?	No	Yes	Gutter Slope (%)	3.0
Yes	Gutter Lip Ht (in)	0.0	Yes	Gutter X Slope (%)	1.8
N/A	Painted X Walk1?	Yes	N/A	Painted X Walk2?	N/A
	X Walk 1 Direction	To SE		X Walk 2 Direction	N/A
	X Walk 1 Width (in)	106.0		X Walk 2 Width (in)	N/A
	X Walk 1 Slope (%)	0.7		X Walk 2 Slope (%)	N/A
	X Walk 1 X Slope (%)	2.2		X Walk 2 X Slope (%)	N/A

Yes	Ramp inside XWalk1?	Yes	N/A	Ramp inside XWalk2?	N/A
	Road Slope (%)	2.2		Clear Space?	Yes
	Road X Slope (%)	0.7	N/A	Clear Space to XWalk (in)	N/A
Yes	Any Obstructions?	No	Yes	Storm Grate/Utility Hazard?	No
	Obstruction Type			Storm Grate/Utility Type	
		N/A			N/A
			Yes	Surface Condition? (G/P)	Good
			Yes	Curb Slope (%)	4.5

**Remove & Replace Curb Ramp With Two New Directional Ramps or Equivalent.**

**R304.5.3, R305**
