Access Compliance Report

Public Rights-of-Way

(Curb Ramps)

Intersection ID: 1003360	Main Street: HEATHCOTT_CR	Cross Street: N/A	Location: NW
ADA ID: 5A93C4BBF94B	Ramp Type: BlendTrans1	Initial Pass/Fail: Fail	Overall Compliance: No
		Severity Score: 8.75

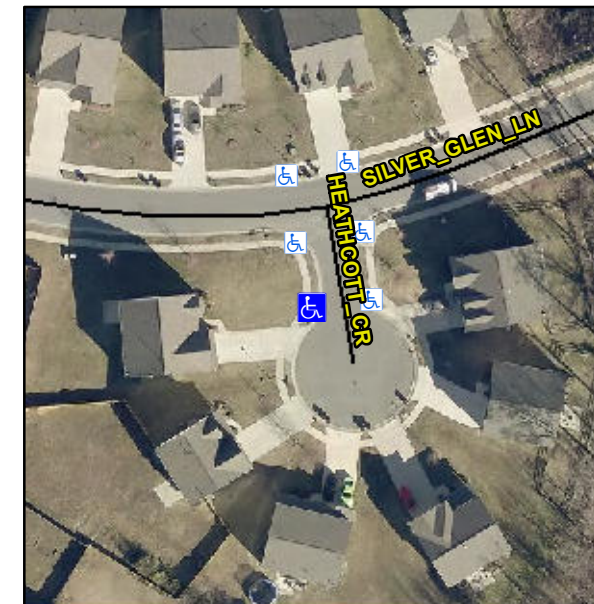
Not Found, R304.5.1

Remove & Replace Curb Ramp With Two New Directional Ramps or Equivalent.

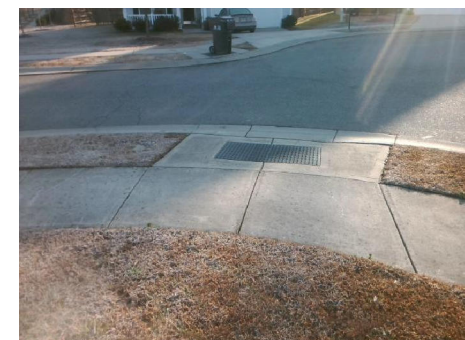
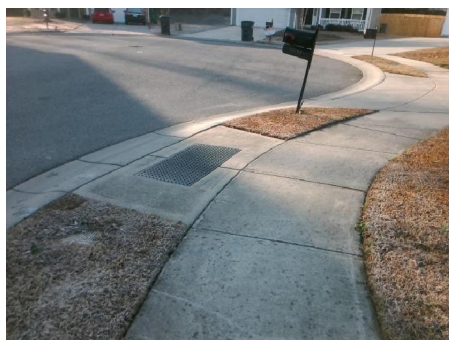
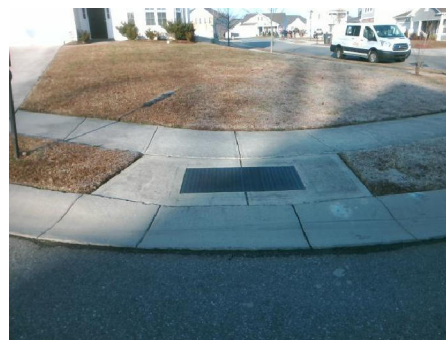
Compliance	Description	Data	Compliance	Description	Data
N/A	Ramp Length (in)	47.5	Yes	BlendTrans Slope (%)	3.2
No	Ramp Width (in)	47.0	Yes	BlendTrans XSlope (%)	0.7
N/A	Flare Type LT	N/A	N/A	Flare Type RT	N/A
N/A	Flare Slope LT (%)	N/A	N/A	Flare Slope RT (%)	N/A
N/A	Flare Traversable LT?	N/A	N/A	Flare Traversable RT?	N/A
N/A	Landing Length (in)	N/A	N/A	DWS Provided?	N/A
N/A	Landing Width (in)	N/A	N/A	DWS Contrast?	N/A
N/A	Landing Slope (%)	N/A	N/A	DWS Length (in)	N/A
N/A	Landing X Slope (%)	N/A	N/A	DWS Full Width?	N/A
N/A	Landing Curb? (Y/N)	N/A	N/A	DWS Offset (in)	N/A
N/A	Shared Landing?	N/A			
N/A	Gutter Ponding?	N/A	N/A	Gutter Slope (%)	N/A
N/A	Gutter Lip Ht (in)	N/A	N/A	Gutter X Slope (%)	N/A
N/A	Painted X Walk1?	No	N/A	Painted X Walk2?	N/A
	X Walk 1 Direction	To E		X Walk 2 Direction	N/A
	X Walk 1 Width (in)	N/A		X Walk 2 Width (in)	N/A
	X Walk 1 Slope (%)	3.5		X Walk 2 Slope (%)	N/A
	X Walk 1 X Slope (%)	3.2		X Walk 2 X Slope (%)	N/A

N/A	Ramp inside XWalk1?	N/A	N/A	Ramp inside XWalk2?	N/A
	Road Slope (%)	3.2		Clear Space?	N/A
	Road X Slope (%)	3.5	N/A	Clear Space to XWalk (in)	N/A
N/A	Any Obstructions?	N/A	N/A	Storm Grate/Utility Hazard?	N/A
	Obstruction Type			Storm Grate/Utility Type	
		N/A			N/A
			Yes	Surface Condition? (G/P)	Good
			No	Curb Slope (%)	9.4
