Access Compliance Report

Public Rights-of-Way

(Curb Ramps)

Intersection ID: 27536	Main Street: DOWINGTON_DR	Cross Street: WOODRIVER_LN	Location: NE
ADA ID: 5A9614FBFD25	Ramp Type: PerpDiag	Initial Pass/Fail: Fail	Overall Compliance: No
Severity Score: 46.25			
Codes/Mitigation Info/Possible Solution		Field Measurements/Component Compliance

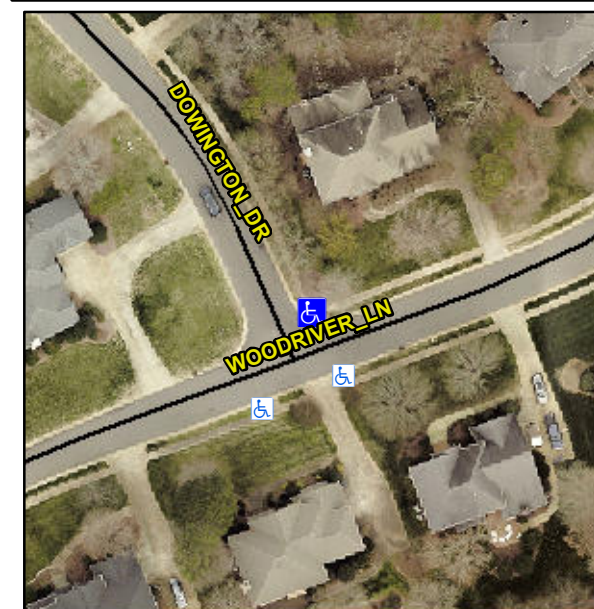
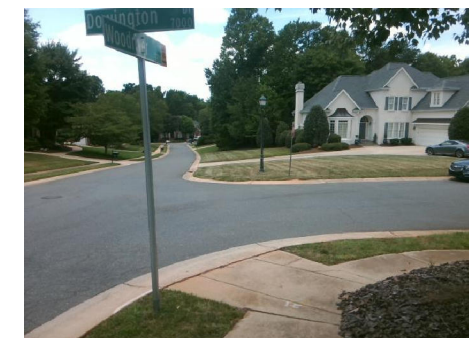
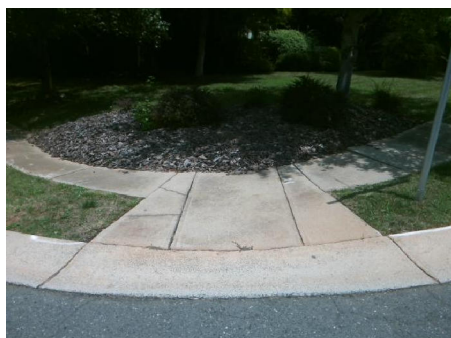
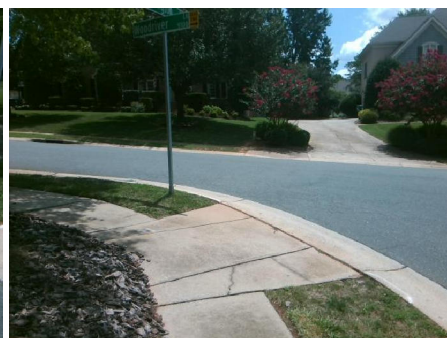
Not Found, R304.5.1, R304.2.2, R304.5.3

Compliance	Description	Data	Compliance	Description	Data
N/A	Ramp Length (in)	92.0	No	Ramp Slope (%)	8.5
No	Ramp Width (in)	46.0	No	Ramp XSlope (%)	10.2
N/A	Flare Type LT	N/A	N/A	Flare Type RT	N/A
N/A	Flare Slope LT (%)	N/A	N/A	Flare Slope RT (%)	N/A
N/A	Flare Traversable LT?	N/A	N/A	Flare Traversable RT?	N/A
N/A	Landing Length (in)	N/A	N/A	DWS Provided?	N/A
N/A	Landing Width (in)	N/A	N/A	DWS Contrast?	N/A
N/A	Landing Slope (%)	N/A	N/A	DWS Length (in)	N/A
N/A	Landing X Slope (%)	N/A	N/A	DWS Full Width?	N/A
N/A	Landing Curb? (Y/N)	N/A	N/A	DWS Offset (in)	N/A
N/A	Shared Landing?	N/A			
N/A	Gutter Ponding?	N/A	N/A	Gutter Slope (%)	N/A
N/A	Gutter Lip Ht (in)	N/A	N/A	Gutter X Slope (%)	N/A
N/A	Painted X Walk1?	No	N/A	Painted X Walk2?	No
	X Walk 1 Direction	To W		X Walk 2 Direction	To S
N/A	X Walk 1 Width (in)	N/A	N/A	X Walk 2 Width (in)	N/A
	X Walk 1 Slope (%)	4.2		X Walk 2 Slope (%)	2.4
	X Walk 1 X Slope (%)	4.6		X Walk 2 X Slope (%)	8.7

N/A	Ramp inside XWalk1?	N/A	N/A	Ramp inside XWalk2?	N/A
	Road Slope (%)	9.0	N/A	Clear Space?	N/A
	Road X Slope (%)	4.1	N/A	Clear Space to XWalk (in)	N/A
N/A	Any Obstructions?	N/A	N/A	Storm Grate/Utility Hazard?	N/A
	Obstruction Type			Storm Grate/Utility Type	
		N/A			N/A
			Yes	Surface Condition? (G/P)	Good

Remove & Replace Curb Ramp With Two New Directional Ramps or Equivalent.
