# Access Compliance Report

## Public Rights-of-Way

### (Curb Ramps)

Intersection ID: 8424	Main Street: HAINES_ST	Cross Street: LASALLE_ST	Location: SE
ADA ID: 5A9E989A42D8	Ramp Type: Perp	Initial Pass/Fail: Fail	Overall Compliance: No
			Severity Score: 26.25

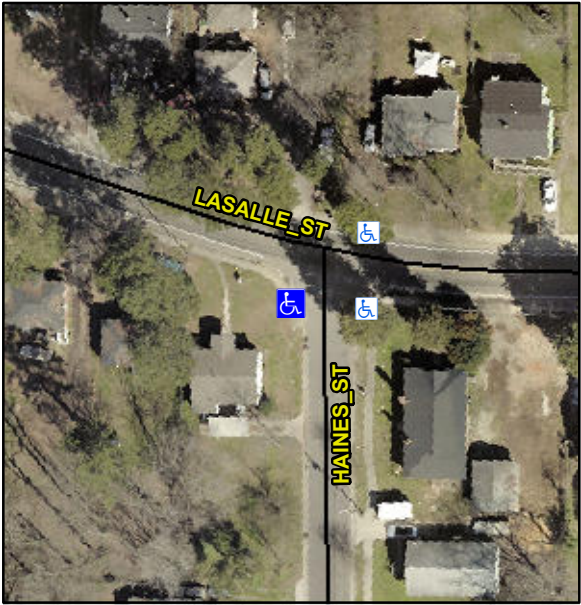
Possible Solutions:		<b>Compliance</b>	<b>Description</b>	<b>Data</b>
	Remove & Replace Entire Ramp.		N/A	Ramp Length (in)	59.0
			Yes	Ramp Width (in)	52.0
			N/A	Flare Type LT	N/A
			N/A	Flare Slope LT (%)	N/A
			N/A	Flare Traversable LT?	N/A
			N/A	Landing Length (in)	N/A
			N/A	Landing Width (in)	N/A
			N/A	Landing Slope (%)	N/A
			N/A	Landing X Slope (%)	N/A
<p>Surveyor Notes:</p> <p>N/A</p> <p>PROW/ADA:</p> <p>R304.2.2, R304.5.3</p>			N/A	Flare Type RT	N/A
			N/A	Flare Slope RT (%)	N/A
			N/A	Flare Traversable RT?	N/A
			N/A	DWS Provided?	N/A
			N/A	DWS Contrast?	N/A
			N/A	DWS Length (in)	N/A
			N/A	DWS Full Width?	N/A
			N/A	DWS Offset (in)	N/A
			N/A	Gutter Ponding?	N/A
			N/A	Gutter Lip Ht (in)	N/A
			N/A	Painted X Walk1?	No
				X Walk 1 Direction	To W
			N/A	X Walk 1 Width (in)	N/A
				X Walk 1 Slope (%)	0.4
				X Walk 1 X Slope (%)	1.0

N/A	Ramp inside XWalk1?	N/A
				Road Slope (%)	N/A
				Road X Slope (%)	N/A
			N/A	Any Obstructions?	N/A
				Obstruction Type	
Total Cost:			\$	1850.00	
			N/A		N/A
			Yes	Surface Condition? (G/P)	Good
