Access Compliance Report

Public Rights-of-Way

(Curb Ramps)

Intersection ID: N/A	Main Street: SOLAR_WY	Cross Street: ROCK_ISLAND_RD	Location: NW
ADA ID: 5AA4DF5FA500	Ramp Type: BlendTrans1	Initial Pass/Fail: Fail	Overall Compliance: No
		Severity Score: 10

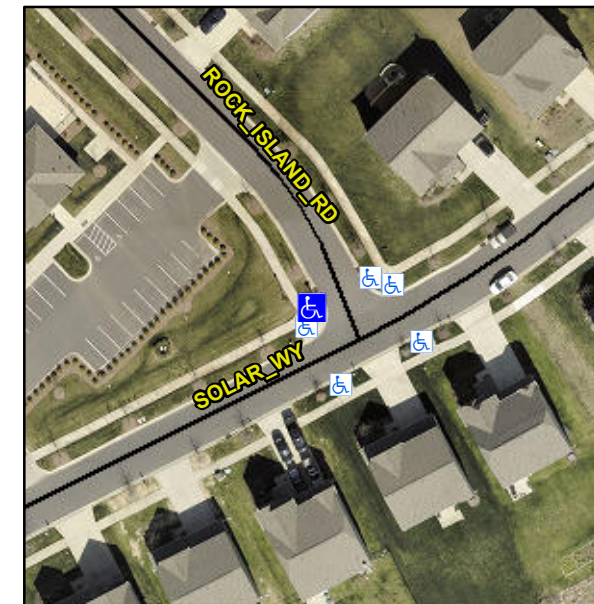
R304.5.1, R304.5.3

Compliance	Description	Data	Compliance	Description	Data
N/A	Ramp Length (in)	104.0	Yes	BlendTrans Slope (%)	1.3
No	Ramp Width (in)	46.5	No	BlendTrans XSlope (%)	3.7
N/A	Flare Type LT	N/A	N/A	Flare Type RT	N/A
N/A	Flare Slope LT (%)	N/A	N/A	Flare Slope RT (%)	N/A
N/A	Flare Traversable LT?	N/A	N/A	Flare Traversable RT?	N/A
N/A	Landing Length (in)	N/A	N/A	DWS Provided?	N/A
N/A	Landing Width (in)	N/A	N/A	DWS Contrast?	N/A
N/A	Landing Slope (%)	N/A	N/A	DWS Length (in)	N/A
N/A	Landing X Slope (%)	N/A	N/A	DWS Full Width?	N/A
N/A	Landing Curb? (Y/N)	N/A	N/A	DWS Offset (in)	N/A
N/A	Shared Landing?	N/A			
N/A	Gutter Ponding?	N/A	N/A	Gutter Slope (%)	N/A
N/A	Gutter Lip Ht (in)	N/A	N/A	Gutter X Slope (%)	N/A
N/A	Painted X Walk1?	No	N/A	Painted X Walk2?	N/A
	X Walk 1 Direction	To NE		X Walk 2 Direction	N/A
	X Walk 1 Width (in)	N/A		X Walk 2 Width (in)	N/A
	X Walk 1 Slope (%)	3.3		X Walk 2 Slope (%)	N/A
	X Walk 1 X Slope (%)	1.8		X Walk 2 X Slope (%)	N/A

N/A	Ramp inside XWalk1?	N/A	N/A	Ramp inside XWalk2?	N/A
	Road Slope (%)	1.8		Clear Space?	N/A
	Road X Slope (%)	3.3	N/A	Clear Space to XWalk (in)	N/A
N/A	Any Obstructions?	N/A	N/A	Storm Grate/Utility Hazard?	N/A
	Obstruction Type			Storm Grate/Utility Type	
		N/A			N/A
			Yes	Surface Condition? (G/P)	Good
			N/A	Curb Slope (%)	3.5

Remove & Replace Curb Ramp With Two New Directional Ramps or Equivalent.
