Access Compliance Report

Public Rights-of-Way

(Curb Ramps)

Intersection ID: 21320	Main Street: FREDERICK_PL	Cross Street: PARK_RD	Location: NW
ADA ID: 5AB155EFE6FE	Ramp Type: PerpDiag	Initial Pass/Fail: Fail	Overall Compliance: No
		Severity Score: 10

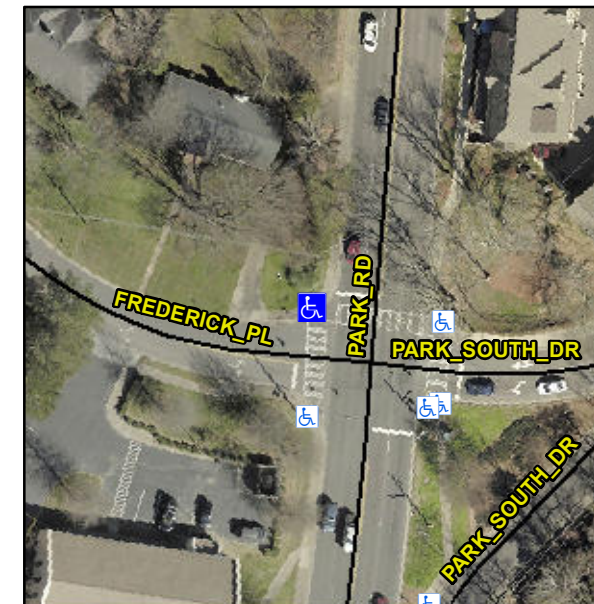
Not Found, R304.5.1, R304.5.3

Compliance	Description	Data	Compliance	Description	Data
N/A	Ramp Length (in)	59.0	Yes	Ramp Slope (%)	7.9
No	Ramp Width (in)	41.0	No	Ramp XSlope (%)	3.9
N/A	Flare Type LT	N/A	N/A	Flare Type RT	N/A
N/A	Flare Slope LT (%)	N/A	N/A	Flare Slope RT (%)	N/A
N/A	Flare Traversable LT?	N/A	N/A	Flare Traversable RT?	N/A
N/A	Landing Length (in)	N/A	N/A	DWS Provided?	N/A
N/A	Landing Width (in)	N/A	N/A	DWS Contrast?	N/A
N/A	Landing Slope (%)	N/A	N/A	DWS Length (in)	N/A
N/A	Landing X Slope (%)	N/A	N/A	DWS Full Width?	N/A
N/A	Landing Curb? (Y/N)	N/A	N/A	DWS Offset (in)	N/A
N/A	Shared Landing?	N/A			
N/A	Gutter Ponding?	N/A	N/A	Gutter Slope (%)	N/A
N/A	Gutter Lip Ht (in)	N/A	N/A	Gutter X Slope (%)	N/A
N/A	Painted X Walk1?	Yes	N/A	Painted X Walk2?	Yes
	X Walk 1 Direction	To SW		X Walk 2 Direction	To SE
N/A	X Walk 1 Width (in)	110.0	N/A	X Walk 2 Width (in)	110.0
	X Walk 1 Slope (%)	0.2		X Walk 2 Slope (%)	2.8
	X Walk 1 X Slope (%)	2.7		X Walk 2 X Slope (%)	1.1

N/A	Ramp inside XWalk1?	Yes	N/A	Ramp inside XWalk2?	Yes
	Road Slope (%)	2.2	N/A	Clear Space?	N/A
	Road X Slope (%)	2.0	N/A	Clear Space to XWalk (in)	N/A
N/A	Any Obstructions?	N/A	N/A	Storm Grate/Utility Hazard?	N/A
	Obstruction Type			Storm Grate/Utility Type	
		N/A			N/A
		Yes		Surface Condition? (G/P)	Good

Possible Solutions:

Remove & Replace Curb Ramp With Two New Directional Ramps or Equivalent.
