# Access Compliance Report

## Public Rights-of-Way

### (Curb Ramps)

Intersection ID: 46490	Main Street: BERE_ISLAND_DR	Cross Street: BALLYBAY_DR	Location: SW
ADA ID: 5AB38DDE5678	Ramp Type: Perp	Initial Pass/Fail: Fail	Overall Compliance: No
Severity Score: 8.75			
Codes/Mitigation Info/Possible Solution		Field Measurements/Component Compliance

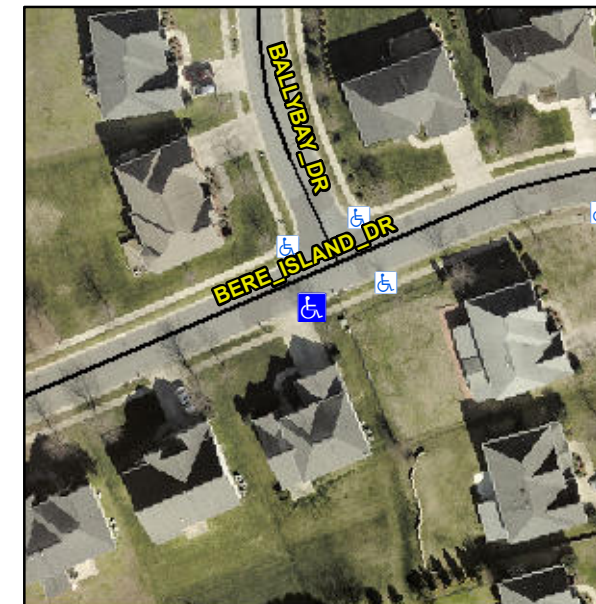
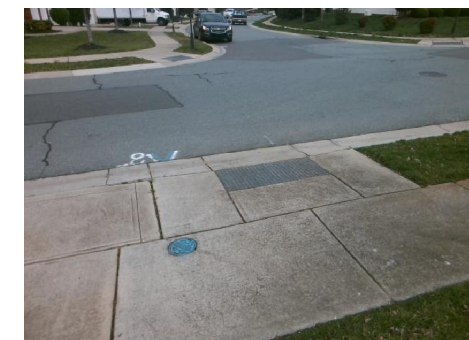
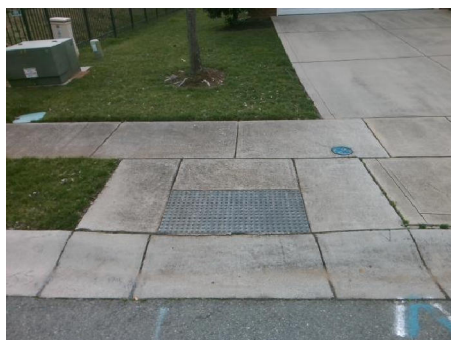
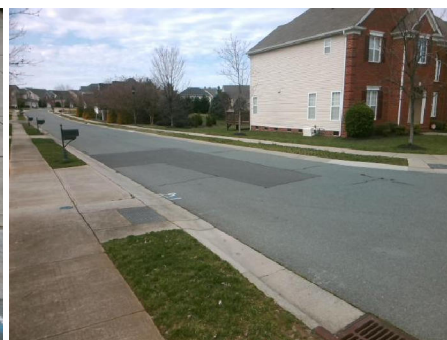
**Not Found, R304.5.1**

Compliance	Description	Data	Compliance	Description	Data
N/A	Ramp Length (in)	50.0	Yes	Ramp Slope (%)	6.1
No	Ramp Width (in)	47.0	Yes	Ramp XSlope (%)	1.5
N/A	Flare Type LT	N/A	N/A	Flare Type RT	N/A
N/A	Flare Slope LT (%)	N/A	N/A	Flare Slope RT (%)	N/A
N/A	Flare Traversable LT?	N/A	N/A	Flare Traversable RT?	N/A
N/A	Landing Length (in)	N/A	N/A	DWS Provided?	N/A
N/A	Landing Width (in)	N/A	N/A	DWS Contrast?	N/A
N/A	Landing Slope (%)	N/A	N/A	DWS Length (in)	N/A
N/A	Landing X Slope (%)	N/A	N/A	DWS Full Width?	N/A
N/A	Landing Curb? (Y/N)	N/A	N/A	DWS Offset (in)	N/A
N/A	Shared Landing?	N/A			
N/A	Gutter Ponding?	N/A	N/A	Gutter Slope (%)	N/A
N/A	Gutter Lip Ht (in)	N/A	N/A	Gutter X Slope (%)	N/A
N/A	Painted X Walk1?	No	N/A	Painted X Walk2?	N/A
	X Walk 1 Direction	To NW		X Walk 2 Direction	N/A
N/A	X Walk 1 Width (in)	N/A	N/A	X Walk 2 Width (in)	N/A
	X Walk 1 Slope (%)	1.4		X Walk 2 Slope (%)	N/A
	X Walk 1 X Slope (%)	1.0		X Walk 2 X Slope (%)	N/A

N/A	Ramp inside XWalk1?	N/A	N/A	Ramp inside XWalk2?	N/A
	Road Slope (%)	N/A	N/A	Clear Space?	N/A
	Road X Slope (%)	N/A	N/A	Clear Space to XWalk (in)	N/A
N/A	Any Obstructions?	N/A	N/A	Storm Grate/Utility Hazard?	N/A
	Obstruction Type			Storm Grate/Utility Type	
		N/A			N/A
			Yes	Surface Condition? (G/P)	Good

**Remove & Replace Entire Ramp.**

Total Cost: \$ 1850.00
