# Access Compliance Report

## Public Rights-of-Way

### (Curb Ramps)

Intersection ID: 18086	Main Street: NATIONS_FORD_RD	Cross Street: RADFORD_AV	Location: SW
ADA ID: 5AB55F430C8E	Ramp Type: Directional1	Initial Pass/Fail: Fail	Overall Compliance: No
		Severity Score: 12.5

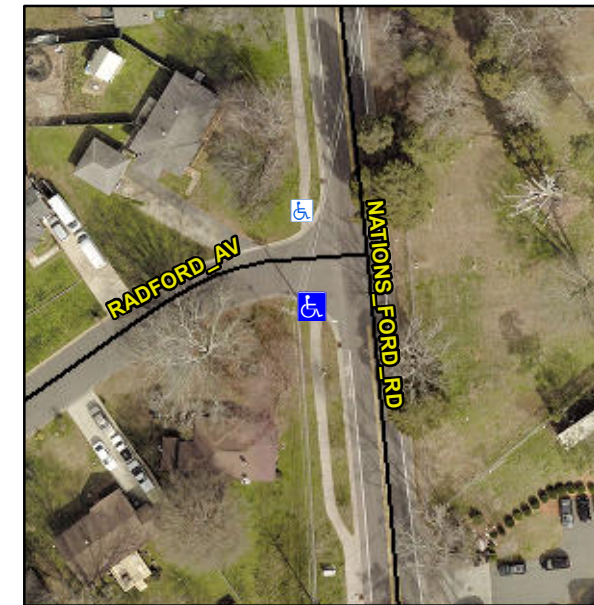
Compliance	Description	Data	Compliance	Description	Data
N/A	Ramp Length (in)	102.0	N/A	Grade Break?	N/A
Yes	Ramp Width (in)	71.0	N/A	Grade Break Slope (%)	0.0
No	Ramp Slope (%)	10.1	N/A	Grade Break XSlope (%)	0.0
Yes	Ramp XSlope (%)	1.9			
N/A	Flare Type LT	N/A	N/A	Flare Type RT	N/A
N/A	Flare Slope LT (%)	N/A	N/A	Flare Slope RT (%)	0.0
N/A	Flare Traversable LT?	N/A	N/A	Flare Traversable RT?	N/A
N/A	Landing Length (in)	0.0	N/A	DWS Provided?	N/A
N/A	Landing Width (in)	0.0	N/A	DWS Contrast?	N/A
N/A	Landing Slope (%)	0.0	N/A	DWS Length (in)	N/A
N/A	Landing X Slope (%)	0.0	N/A	DWS Full Width?	N/A
N/A	Landing Curb? (Y/N)	N/A	N/A	DWS Offset LT (in)	N/A
N/A	Shared Landing?	N/A	N/A	DWS Offset RT (in)	N/A
N/A	Gutter Ponding?	0.0	N/A	Gutter Slope (%)	N/A
N/A	Gutter Lip Ht (in)	0.0	N/A	Gutter X Slope (%)	N/A
N/A	Painted X Walk1?	No		Road Slope (%)	1.4
	X Walk 1 Direction	To NW		Road X Slope (%)	3.2
	X Walk 1 Width (in)	N/A		Clear Space?	N/A

X Walk 1 Slope (%)	1.4	N/A	Clear Space to XWalk (in)	N/A
	X Walk 1 X Slope (%)	3.2	N/A	Storm Grate/Utility Hazard?	N/A
N/A	Ramp inside XWalk1?	N/A		Storm Grate/Utility Type	
N/A	Any Obstructions?	N/A			N/A
	Obstruction Type		Yes	Surface Condition? (G/P)	Good
			N/A	Curb Slope (%)	5.0

**Remove & Replace Entire Ramp.**

**R304.2.2**

\$ 1600.00
