Access Compliance Report

Public Rights-of-Way

(Curb Ramps)

Intersection ID: 42929	Main Street: BRAY_DR	Cross Street: KILRUSH_DR	Location: SW
ADA ID: 5AB6B246B310	Ramp Type: PerpDiag	Initial Pass/Fail: Fail	Overall Compliance: No
		Severity Score: 37.5

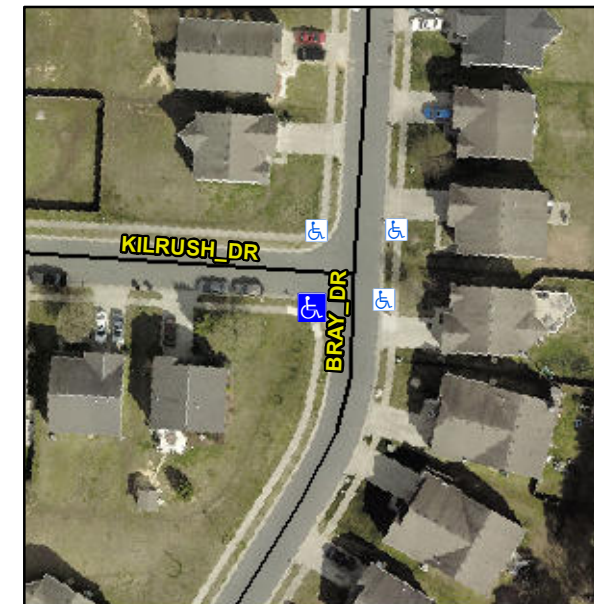
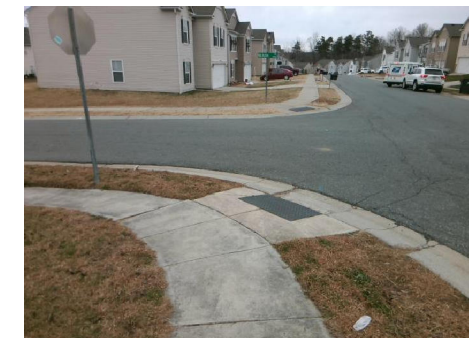
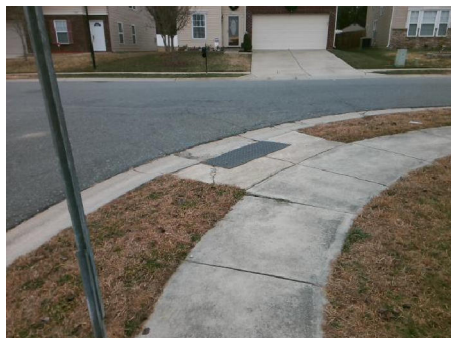
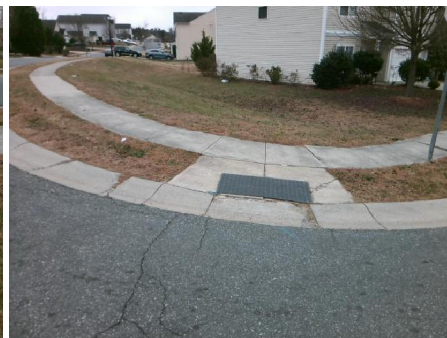
Not Found, R304.2.2, R304.5.3

Compliance	Description	Data	Compliance	Description	Data
N/A	Ramp Length (in)	46.0	No	Ramp Slope (%)	9.0
Yes	Ramp Width (in)	48.0	No	Ramp XSlope (%)	7.4
N/A	Flare Type LT	N/A	N/A	Flare Type RT	N/A
N/A	Flare Slope LT (%)	N/A	N/A	Flare Slope RT (%)	N/A
N/A	Flare Traversable LT?	N/A	N/A	Flare Traversable RT?	N/A
N/A	Landing Length (in)	N/A	N/A	DWS Provided?	N/A
N/A	Landing Width (in)	N/A	N/A	DWS Contrast?	N/A
N/A	Landing Slope (%)	N/A	N/A	DWS Length (in)	N/A
N/A	Landing X Slope (%)	N/A	N/A	DWS Full Width?	N/A
N/A	Landing Curb? (Y/N)	N/A	N/A	DWS Offset (in)	N/A
N/A	Shared Landing?	N/A			
N/A	Gutter Ponding?	N/A	N/A	Gutter Slope (%)	N/A
N/A	Gutter Lip Ht (in)	N/A	N/A	Gutter X Slope (%)	N/A
N/A	Painted X Walk1?	No	N/A	Painted X Walk2?	No
	X Walk 1 Direction	To E		X Walk 2 Direction	To N
N/A	X Walk 1 Width (in)	N/A	N/A	X Walk 2 Width (in)	N/A
	X Walk 1 Slope (%)	3.4		X Walk 2 Slope (%)	2.3
	X Walk 1 X Slope (%)	1.7		X Walk 2 X Slope (%)	5.9

N/A	Ramp inside XWalk1?	N/A	N/A	Ramp inside XWalk2?	N/A
	Road Slope (%)	7.2	N/A	Clear Space?	N/A
	Road X Slope (%)	4.4	N/A	Clear Space to XWalk (in)	N/A
N/A	Any Obstructions?	N/A	N/A	Storm Grate/Utility Hazard?	N/A
	Obstruction Type			Storm Grate/Utility Type	
		N/A			N/A
			Yes	Surface Condition? (G/P)	Good

Remove & Replace Curb Ramp With Two New Directional Ramps or Equivalent.
