Access Compliance Report

Public Rights-of-Way

(Curb Ramps)

Intersection ID: 6744	Main Street: DUTCHESS_ST	Cross Street: W_SUGAR_CREEK_RD	Location: W
ADA ID: 5ABBEBDD27F8	Ramp Type: Perp	Initial Pass/Fail: Fail	Overall Compliance: No
			Severity Score: 13.75

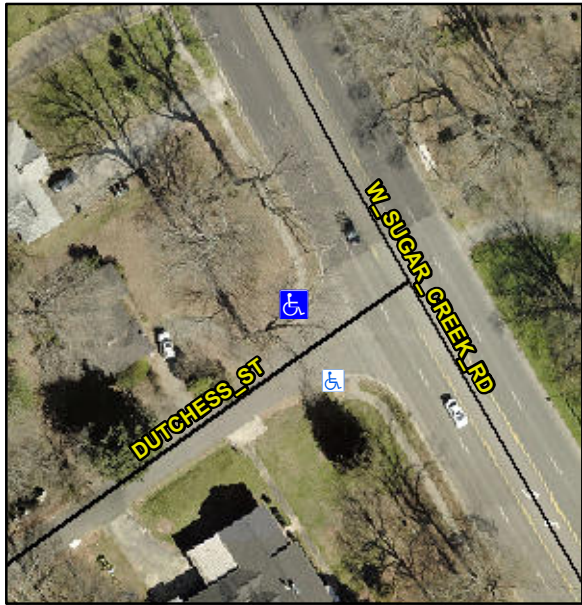
Possible Solutions:		Compliance	Description	Data	Compliance	Description	Data
	Remove & Replace Entire Ramp.		N/A	Ramp Length (in)	72.0	No	Ramp Slope (%)	8.4
			Yes	Ramp Width (in)	48.0	No	Ramp XSlope (%)	2.6
			N/A	Flare Type LT	N/A	N/A	Flare Type RT	N/A
			N/A	Flare Slope LT (%)	N/A	N/A	Flare Slope RT (%)	N/A
			N/A	Flare Traversable LT?	N/A	N/A	Flare Traversable RT?	N/A
			N/A	Landing Length (in)	N/A	N/A	DWS Provided?	N/A
			N/A	Landing Width (in)	N/A	N/A	DWS Contrast?	N/A
			N/A	Landing Slope (%)	N/A	N/A	DWS Length (in)	N/A
			N/A	Landing X Slope (%)	N/A	N/A	DWS Full Width?	N/A
Surveyor Notes:		N/A	N/A	Landing Curb? (Y/N)	N/A	N/A	DWS Offset (in)	N/A
PROW/ADA:		Not Found, R304.2.2, R304.5.3	N/A	Shared Landing?	N/A			
			N/A	Gutter Ponding?	N/A	N/A	Gutter Slope (%)	N/A
			N/A	Gutter Lip Ht (in)	N/A	N/A	Gutter X Slope (%)	N/A

N/A	Painted X Walk1?	No	N/A	Painted X Walk2?	N/A
				X Walk 1 Direction	To S		X Walk 2 Direction	N/A
			N/A	X Walk 1 Width (in)	N/A	N/A	X Walk 2 Width (in)	N/A
				X Walk 1 Slope (%)	1.2		X Walk 2 Slope (%)	N/A
				X Walk 1 X Slope (%)	1.3		X Walk 2 X Slope (%)	N/A
Street 1 Name		DUTCHESS ST	N/A	Ramp inside XWalk1?	N/A	N/A	Ramp inside XWalk2?	N/A
Stop Condition-Street 2		StopSign		Road Slope (%)	N/A	N/A	Clear Space?	N/A
Street 2 Name		N/A		Road X Slope (%)	N/A	N/A	Clear Space to XWalk (in)	N/A
Stop Condition-Street 1		N/A		Any Obstructions?	N/A	N/A	Storm Grate/Utility Hazard?	N/A
				Obstruction Type			Storm Grate/Utility Type	
Total Cost:		\$ 1850.00			N/A			N/A
						Yes	Surface Condition? (G/P)	Good
