Access Compliance Report

Public Rights-of-Way

(Curb Ramps)

Intersection ID: 16973	Main Street: JUDITH_CT	Cross Street: WALKER_RD	Location: NW
ADA ID: 5ABDCA03B7F6	Ramp Type: PerpDiag	Initial Pass/Fail: Fail	Overall Compliance: No
Severity Score: 10			
Codes/Mitigation Info/Possible Solution		Field Measurements/Component Compliance

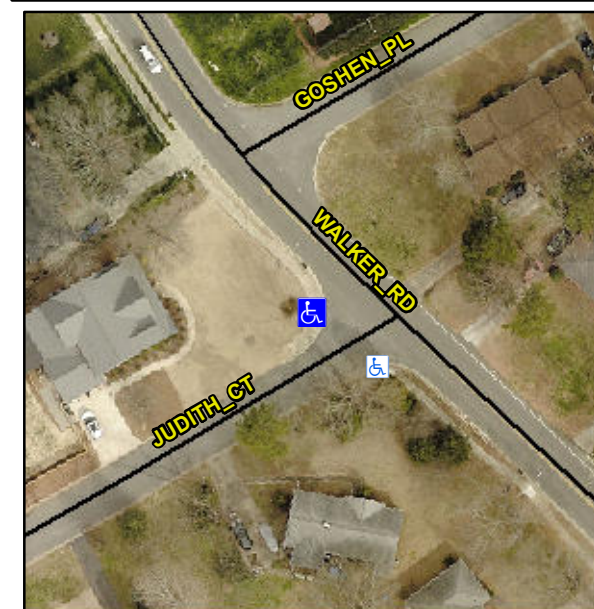
Not Found, R304.5.1, R304.5.3

Compliance	Description	Data	Compliance	Description	Data
N/A	Ramp Length (in)	27.0	Yes	Ramp Slope (%)	8.0
No	Ramp Width (in)	44.0	No	Ramp XSlope (%)	4.6
N/A	Flare Type LT	N/A	N/A	Flare Type RT	N/A
N/A	Flare Slope LT (%)	N/A	N/A	Flare Slope RT (%)	N/A
N/A	Flare Traversable LT?	N/A	N/A	Flare Traversable RT?	N/A
N/A	Landing Length (in)	N/A	N/A	DWS Provided?	N/A
N/A	Landing Width (in)	N/A	N/A	DWS Contrast?	N/A
N/A	Landing Slope (%)	N/A	N/A	DWS Length (in)	N/A
N/A	Landing X Slope (%)	N/A	N/A	DWS Full Width?	N/A
N/A	Landing Curb? (Y/N)	N/A	N/A	DWS Offset (in)	N/A
N/A	Shared Landing?	N/A			
N/A	Gutter Ponding?	N/A	N/A	Gutter Slope (%)	N/A
N/A	Gutter Lip Ht (in)	N/A	N/A	Gutter X Slope (%)	N/A
N/A	Painted X Walk1?	No	N/A	Painted X Walk2?	No
	X Walk 1 Direction	To SE		X Walk 2 Direction	To E
N/A	X Walk 1 Width (in)	N/A	N/A	X Walk 2 Width (in)	N/A
	X Walk 1 Slope (%)	1.4		X Walk 2 Slope (%)	4.6
	X Walk 1 X Slope (%)	2.3		X Walk 2 X Slope (%)	1.4

N/A	Ramp inside XWalk1?	N/A	N/A	Ramp inside XWalk2?	N/A
	Road Slope (%)	2.9	N/A	Clear Space?	N/A
	Road X Slope (%)	2.0	N/A	Clear Space to XWalk (in)	N/A
N/A	Any Obstructions?	N/A	N/A	Storm Grate/Utility Hazard?	N/A
	Obstruction Type			Storm Grate/Utility Type	
		N/A			N/A
			Yes	Surface Condition? (G/P)	Good

Remove & Replace Curb Ramp With Two New Directional Ramps or Equivalent.
