Access Compliance Report

Public Rights-of-Way

(Curb Ramps)

Intersection ID: 15187	Main Street: FORTUNE_ST	Cross Street: MONROE_RD	Location: E
ADA ID: 5AC2E7D79757	Ramp Type: Perp	Initial Pass/Fail: Fail	Overall Compliance: No
Severity Score: 48.75			
Codes/Mitigation Info/Possible Solution		Field Measurements/Component Compliance

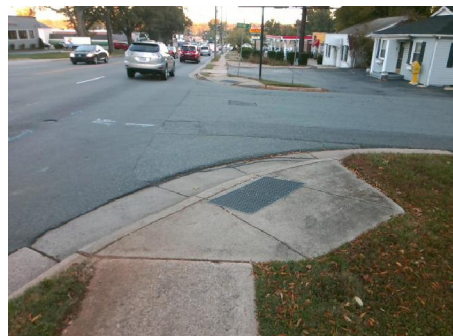
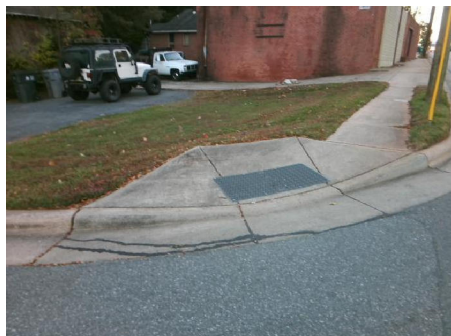
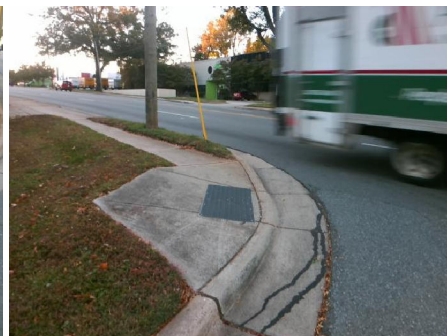
Not Found, R304.5.1, R304.2.2, R304.5.3

Compliance	Description	Data	Compliance	Description	Data
N/A	Ramp Length (in)	73.0	No	Ramp Slope (%)	9.5
No	Ramp Width (in)	24.0	No	Ramp XSlope (%)	4.8
N/A	Flare Type LT	N/A	N/A	Flare Type RT	N/A
N/A	Flare Slope LT (%)	N/A	N/A	Flare Slope RT (%)	N/A
N/A	Flare Traversable LT?	N/A	N/A	Flare Traversable RT?	N/A
N/A	Landing Length (in)	N/A	N/A	DWS Provided?	N/A
N/A	Landing Width (in)	N/A	N/A	DWS Contrast?	N/A
N/A	Landing Slope (%)	N/A	N/A	DWS Length (in)	N/A
N/A	Landing X Slope (%)	N/A	N/A	DWS Full Width?	N/A
N/A	Landing Curb? (Y/N)	N/A	N/A	DWS Offset (in)	N/A
N/A	Shared Landing?	N/A			
N/A	Gutter Ponding?	N/A	N/A	Gutter Slope (%)	N/A
N/A	Gutter Lip Ht (in)	2.0	N/A	Gutter X Slope (%)	N/A
N/A	Painted X Walk1?	No	N/A	Painted X Walk2?	N/A
	X Walk 1 Direction	To NW		X Walk 2 Direction	N/A
N/A	X Walk 1 Width (in)	N/A	N/A	X Walk 2 Width (in)	N/A
	X Walk 1 Slope (%)	0.0		X Walk 2 Slope (%)	N/A
	X Walk 1 X Slope (%)	6.1		X Walk 2 X Slope (%)	N/A

N/A	Ramp inside XWalk1?	N/A	N/A	Ramp inside XWalk2?	N/A
	Road Slope (%)	N/A	N/A	Clear Space?	N/A
	Road X Slope (%)	N/A	N/A	Clear Space to XWalk (in)	N/A
N/A	Any Obstructions?	N/A	N/A	Storm Grate/Utility Hazard?	N/A
	Obstruction Type			Storm Grate/Utility Type	
		N/A			N/A
			Yes	Surface Condition? (G/P)	Good

Remove & Replace Entire Ramp.
