Access Compliance Report Public Rights-of-Way (Curb Ramps)

Intersection ID: 4051 Main Street: MT_ISLE_HARBOR_DR Cross Street: SHADY_REACH_LN Location: S

ADA ID: 5AC32A6ECD8D Ramp Type: Perp Initial Pass/Fail: Fail Overall Compliance: No Severity Score: 10

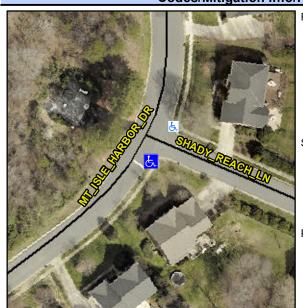
R304.5.1, R304.5.3

Compliance Description		Data			Description	Data
N/A	Ramp Length (in)	54.0	Yes	Ramp	Slope (%)	6.6
No	Ramp Width (in)	47.0	No	Ramp	XSlope (%)	3.0
N/A	Flare Type LT	N/A	N/A	Flare	Type RT	N/A
N/A	Flare Slope LT (%)	N/A	N/A	Flare	Slope RT (%)	N/A
N/A	Flare Traversable LT?	N/A	N/A	Flare	Traversable RT?	N/A
N/A	Landing Length (in)	N/A	N/A	DWS	Provided?	N/A
N/A	Landing Width (in)	N/A	N/A	DWS	Contrast?	N/A
N/A	Landing Slope (%)	N/A	N/A	DWS	Length (in)	N/A
N/A	Landing X Slope (%)	N/A	N/A	DWS	Full Width?	N/A
N/A	Landing Curb? (Y/N)	N/A	N/A	DWS	Offset (in)	N/A
N/A	Shared Landing?	N/A				
N/A	Gutter Ponding?	N/A	N/A	Gutte	r Slope (%)	N/A
N/A	Gutter Lip Ht (in)	N/A	N/A	Gutte	er X Slope (%)	N/A
N/A	Painted X Walk1?	No	N/A	Paint	ed X Walk2?	N/A
	X Walk 1 Direction	To NE		X Wa	lk 2 Direction	N/A
N/A	X Walk 1 Width (in)	N/A	N/A	X Wa	lk 2 Width (in)	N/A
	X Walk 1 Slope (%)	1.2		X Wa	lk 2 Slope (%)	N/A
	X Walk 1 X Slope (%)	1.0		X Wa	lk 2 X Slope (%)	N/A

Remove & Replace Entire Ramp.
