Access Compliance Report

Public Rights-of-Way

(Curb Ramps)

Intersection ID: 15070	Main Street: IDEAL_WY	Cross Street: REMOUNT_RD	Location: NE
ADA ID: 5AC79641723E	Ramp Type: Perp	Initial Pass/Fail: Fail	Overall Compliance: No
Codes/Mitigation Info/Possible Solution			Severity Score: 25
			Field Measurements/Component Compliance

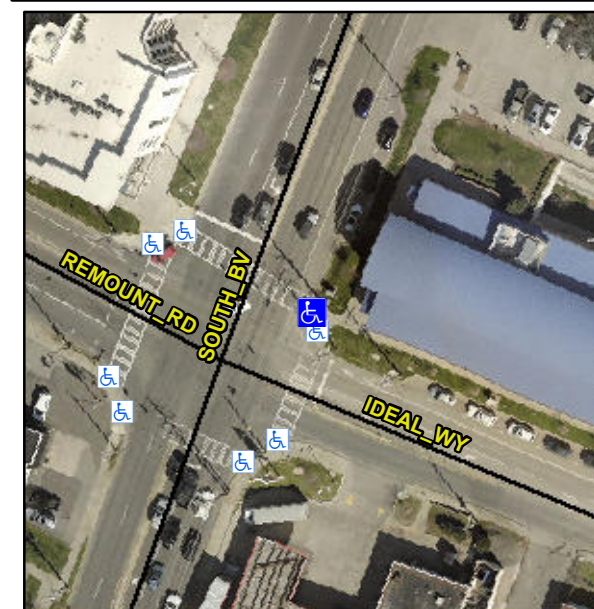
Not Found, R304.5.3

Compliance	Description	Data	Compliance	Description	Data
N/A	Ramp Length (in)	72.0	Yes	Ramp Slope (%)	6.5
Yes	Ramp Width (in)	48.0	No	Ramp XSlope (%)	11.6
N/A	Flare Type LT	N/A	N/A	Flare Type RT	N/A
N/A	Flare Slope LT (%)	N/A	N/A	Flare Slope RT (%)	N/A
N/A	Flare Traversable LT?	N/A	N/A	Flare Traversable RT?	N/A
N/A	Landing Length (in)	N/A	N/A	DWS Provided?	N/A
N/A	Landing Width (in)	N/A	N/A	DWS Contrast?	N/A
N/A	Landing Slope (%)	N/A	N/A	DWS Length (in)	N/A
N/A	Landing X Slope (%)	N/A	N/A	DWS Full Width?	N/A
N/A	Landing Curb? (Y/N)	N/A	N/A	DWS Offset (in)	N/A
N/A	Shared Landing?	N/A			
N/A	Gutter Ponding?	N/A	N/A	Gutter Slope (%)	N/A
N/A	Gutter Lip Ht (in)	N/A	N/A	Gutter X Slope (%)	N/A
N/A	Painted X Walk1?	Yes	N/A	Painted X Walk2?	N/A
	X Walk 1 Direction	To NW		X Walk 2 Direction	N/A
N/A	X Walk 1 Width (in)	112.0	N/A	X Walk 2 Width (in)	N/A
	X Walk 1 Slope (%)	3.8		X Walk 2 Slope (%)	N/A
	X Walk 1 X Slope (%)	5.5		X Walk 2 X Slope (%)	N/A

N/A	Ramp inside XWalk1?	Yes	N/A	Ramp inside XWalk2?	N/A
	Road Slope (%)	N/A	N/A	Clear Space?	N/A
	Road X Slope (%)	N/A	N/A	Clear Space to XWalk (in)	N/A
N/A	Any Obstructions?	N/A	N/A	Storm Grate/Utility Hazard?	N/A
	Obstruction Type			Storm Grate/Utility Type	
		N/A			N/A
		Yes		Surface Condition? (G/P)	Good

Possible Solutions:

Remove & Replace Entire Ramp.

Total Cost: \$ 1850.00
