Access Compliance Report

Public Rights-of-Way

(Curb Ramps)

Intersection ID: 11112	Main Street: WILKINSON_BV	Cross Street: LITTLE ROCK_RD	Location: NW
ADA ID: 5ACD80FF6B3C	Ramp Type: Perp	Initial Pass/Fail: Fail	Overall Compliance: No
		Severity Score: 1.25

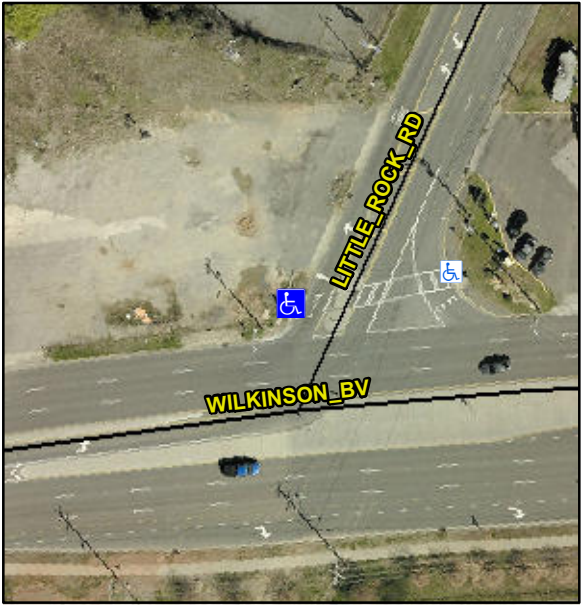
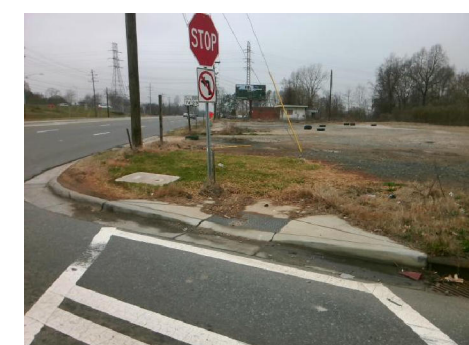
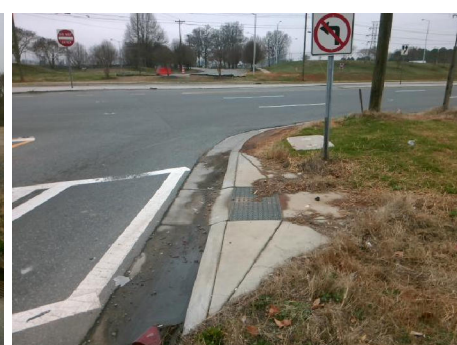
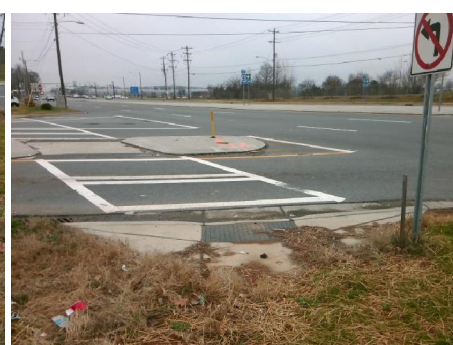
Possible Solutions:		Compliance	Description	Data
	Remove & Replace Entire Ramp.		N/A	Ramp Length (in)	69.0
			Yes	Ramp Width (in)	48.0
			N/A	Flare Type LT	N/A
			N/A	Flare Slope LT (%)	N/A
			N/A	Flare Traversable LT?	N/A
			N/A	Landing Length (in)	N/A
			N/A	Landing Width (in)	N/A
			N/A	Landing Slope (%)	N/A
			N/A	Landing X Slope (%)	N/A
<p>Surveyor Notes:</p> <p>N/A</p> <p>PROW/ADA:</p> <p>Not Found, R304.5.3</p>			N/A	Flare Type RT	N/A
			N/A	Flare Slope RT (%)	N/A
			N/A	Flare Traversable RT?	N/A
			N/A	DWS Provided?	N/A
			N/A	DWS Contrast?	N/A
			N/A	DWS Length (in)	N/A
			N/A	DWS Full Width?	N/A
			N/A	DWS Offset (in)	N/A
			N/A	Shared Landing?	N/A
			N/A	Gutter Ponding?	N/A
			N/A	Gutter Lip Ht (in)	N/A
			N/A	Painted X Walk1?	Yes
				X Walk 1 Direction	To E
			N/A	X Walk 1 Width (in)	112.0
				X Walk 1 Slope (%)	1.6

X Walk 1 X Slope (%)	1.2
			N/A	Ramp inside XWalk1?	Yes
			N/A	Road Slope (%)	N/A
			N/A	Road X Slope (%)	N/A
			N/A	Any Obstructions?	N/A
				Obstruction Type	
Total Cost:		\$ 1850.00			
			N/A		N/A
			Yes	Surface Condition? (G/P)	Good
