# Access Compliance Report

## Public Rights-of-Way

### (Curb Ramps)

| Intersection ID: 49507 | Main Street: OSCEOLA_LN | Cross Street: ANKENY_CT | Location: W |

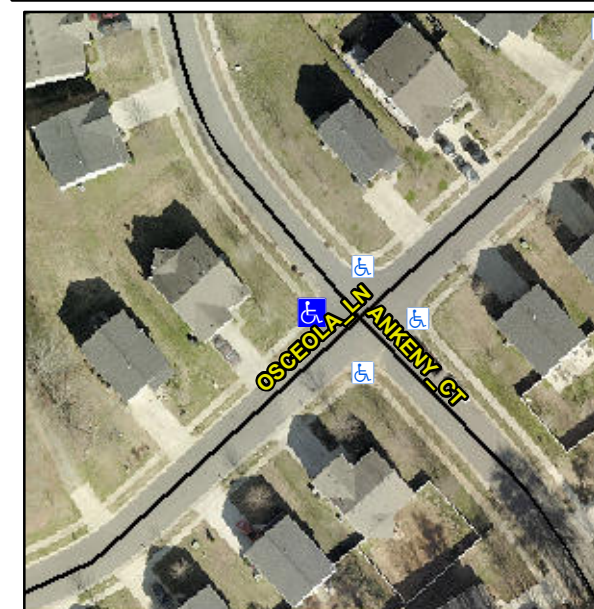
**Not Found, R304.2.2, R304.5.3**

| Compliance | Description | Data | Compliance | Description | Data |
|---|---|---|---|---|---|
| N/A | Ramp Length (in) | 46.5 | No | Ramp Slope (%) | 9.5 |
| Yes | Ramp Width (in) | 48.0 | No | Ramp XSlope (%) | 8.1 |

**Remove & Replace Curb Ramp With Two New Directional Ramps or Equivalent.**
