Access Compliance Report

Public Rights-of-Way

(Curb Ramps)

Intersection ID: 8535	Main Street: BROOKSHIRE_BV	Cross Street: NELSON_AV	Location: S
ADA ID: 5AE42C637ABD	Ramp Type: Perp	Initial Pass/Fail: Fail	Overall Compliance: No
		Severity Score: 12.5

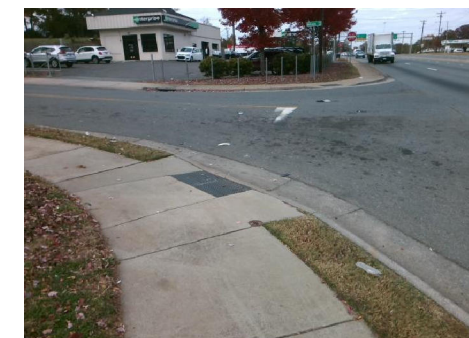
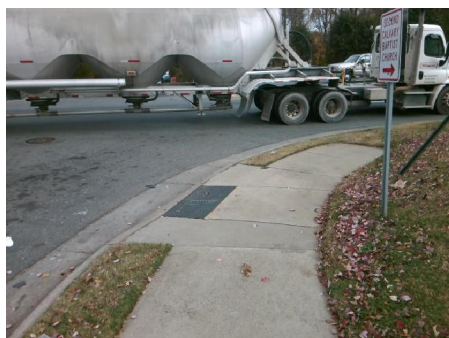
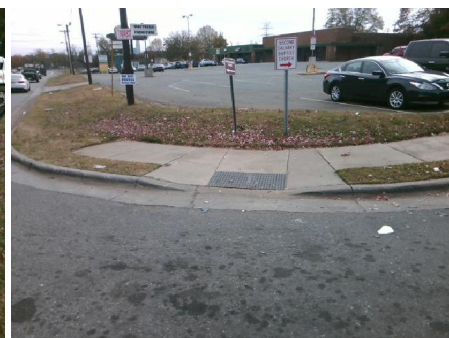
Not Found, R304.2.2

Compliance	Description	Data	Compliance	Description	Data
N/A	Ramp Length (in)	83.0	No	Ramp Slope (%)	9.2
Yes	Ramp Width (in)	48.0	Yes	Ramp XSlope (%)	0.9
N/A	Flare Type LT	N/A	N/A	Flare Type RT	N/A
N/A	Flare Slope LT (%)	N/A	N/A	Flare Slope RT (%)	N/A
N/A	Flare Traversable LT?	N/A	N/A	Flare Traversable RT?	N/A
N/A	Landing Length (in)	N/A	N/A	DWS Provided?	N/A
N/A	Landing Width (in)	N/A	N/A	DWS Contrast?	N/A
N/A	Landing Slope (%)	N/A	N/A	DWS Length (in)	N/A
N/A	Landing X Slope (%)	N/A	N/A	DWS Full Width?	N/A
N/A	Landing Curb? (Y/N)	N/A	N/A	DWS Offset (in)	N/A
N/A	Shared Landing?	N/A			
N/A	Gutter Ponding?	N/A	N/A	Gutter Slope (%)	N/A
N/A	Gutter Lip Ht (in)	N/A	N/A	Gutter X Slope (%)	N/A
N/A	Painted X Walk1?	No	N/A	Painted X Walk2?	N/A
	X Walk 1 Direction	To NW		X Walk 2 Direction	N/A
N/A	X Walk 1 Width (in)	N/A	N/A	X Walk 2 Width (in)	N/A
	X Walk 1 Slope (%)	7.1		X Walk 2 Slope (%)	N/A
	X Walk 1 X Slope (%)	2.2		X Walk 2 X Slope (%)	N/A

N/A	Ramp inside XWalk1?	N/A	N/A	Ramp inside XWalk2?	N/A
	Road Slope (%)	N/A	N/A	Clear Space?	N/A
	Road X Slope (%)	N/A	N/A	Clear Space to XWalk (in)	N/A
N/A	Any Obstructions?	N/A	N/A	Storm Grate/Utility Hazard?	N/A
	Obstruction Type			Storm Grate/Utility Type	
		N/A			N/A
			Yes	Surface Condition? (G/P)	Good

Remove & Replace Entire Ramp.

Total Cost: \$ 1850.00
