Access Compliance Report

Public Rights-of-Way

(Curb Ramps)

Intersection ID: 22519	Main Street: SHARON_RD	Cross Street: AYRSHIRE_PL	Location:	N
ADA ID: 5AE5D2123B05	Ramp Type: PerpDiag	Initial Pass/Fail: Fail	Overall Compliance: No	Severity Score: 10

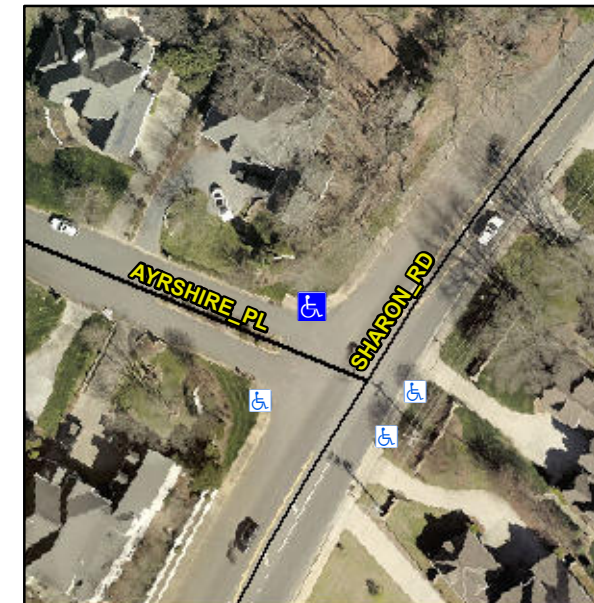
Compliance	Description	Data	Compliance	Description	Data
N/A	Ramp Length (in)	59.0	Yes	Ramp Slope (%)	6.8
No	Ramp Width (in)	45.0	No	Ramp XSlope (%)	4.8
N/A	Flare Type LT	N/A	N/A	Flare Type RT	N/A
N/A	Flare Slope LT (%)	N/A	N/A	Flare Slope RT (%)	N/A
N/A	Flare Traversable LT?	N/A	N/A	Flare Traversable RT?	N/A
N/A	Landing Length (in)	N/A	N/A	DWS Provided?	N/A
N/A	Landing Width (in)	N/A	N/A	DWS Contrast?	N/A
N/A	Landing Slope (%)	N/A	N/A	DWS Length (in)	N/A
N/A	Landing X Slope (%)	N/A	N/A	DWS Full Width?	N/A
N/A	Landing Curb? (Y/N)	N/A	N/A	DWS Offset (in)	N/A
N/A	Shared Landing?	N/A			
N/A	Gutter Ponding?	N/A	N/A	Gutter Slope (%)	N/A
N/A	Gutter Lip Ht (in)	N/A	N/A	Gutter X Slope (%)	N/A
N/A	Painted X Walk1?	No	N/A	Painted X Walk2?	No
	X Walk 1 Direction	To SW		X Walk 2 Direction	To SE
N/A	X Walk 1 Width (in)	N/A	N/A	X Walk 2 Width (in)	N/A
	X Walk 1 Slope (%)	5.2		X Walk 2 Slope (%)	4.0
	X Walk 1 X Slope (%)	2.5		X Walk 2 X Slope (%)	1.6

N/A	Ramp inside XWalk1?	N/A	N/A	Ramp inside XWalk2?	N/A
	Road Slope (%)	0.4	N/A	Clear Space?	N/A
	Road X Slope (%)	6.4	N/A	Clear Space to XWalk (in)	N/A
N/A	Any Obstructions?	N/A	N/A	Storm Grate/Utility Hazard?	N/A
	Obstruction Type			Storm Grate/Utility Type	
		N/A			N/A
			Yes	Surface Condition? (G/P)	Good

Remove & Replace Curb Ramp With Two New Directional Ramps or Equivalent.

R304.5.1, R304.5.3
