Intersection ID: 10025941		Main Street: ELLISON_ST	Cross Street: WACO_ST	Location:		N
ADA ID: 5AE89F93282A		Ramp Type: PerpDiag	Initial Pass/Fail: Fail	Overall Compliance: No	Severity Score:	22.5
Codes/Mitigation Info/Possible Solution			Field Measurements/Component Compliance

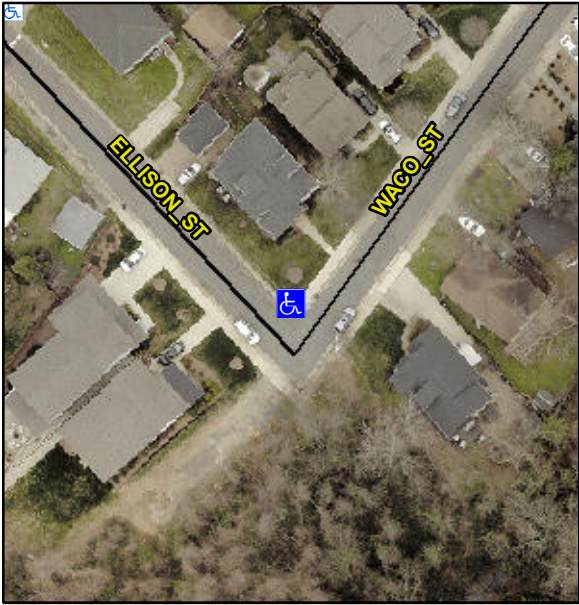
X Walk 1 Slope (%)	2.8	
				X Walk 1 X Slope (%)	0.4	
			N/A	Ramp inside XWalk1?	N/A	N/A
				Road Slope (%)	1.4	N/A
				Road X Slope (%)	4.9	N/A
			N/A	Any Obstructions?	N/A	N/A
				Obstruction Type		
					N/A	N/A
					Yes	Good
Surveyor Notes: N/A						
PROW/ADA: R304.5.1, R304.2.2, R304.5.3						
Total Cost:		\$	3200.00			
Street 1 Name		ELLISON ST				
Stop Condition-Street 2		None				
Street 2 Name		WACO ST				
Stop Condition-Street 1		None

Possible Solutions: Remove & Replace Curb Ramp With Two New Directional Ramps or Equivalent.	Compliance	Description	Data	
			N/A	Ramp Length (in)	69.0	No
			No	Ramp Width (in)	46.5	No
			N/A	Flare Type LT	N/A	N/A
			N/A	Flare Slope LT (%)	N/A	N/A
			N/A	Flare Traversable LT?	N/A	N/A
			N/A	Landing Length (in)	N/A	N/A
			N/A	Landing Width (in)	N/A	N/A
			N/A	Landing Slope (%)	N/A	N/A
			N/A	Landing X Slope (%)	N/A	N/A
			N/A	Landing Curb? (Y/N)	N/A	N/A
			N/A	Shared Landing?	N/A	
			N/A	Gutter Ponding?	N/A	N/A
			N/A	Gutter Lip Ht (in)	N/A	N/A
			N/A	Painted X Walk1?	No	N/A
				X Walk 1 Direction	To SW	
			N/A	X Walk 1 Width (in)	N/A	N/A
