Intersection ID: 10042043	Main Street: WINGET_RD	Cross Street: N/A	Location:	N
ADA ID: 5AE948343214	Ramp Type: PerpDiag	Initial Pass/Fail: Fail	Overall Compliance: No	Severity Score: 35

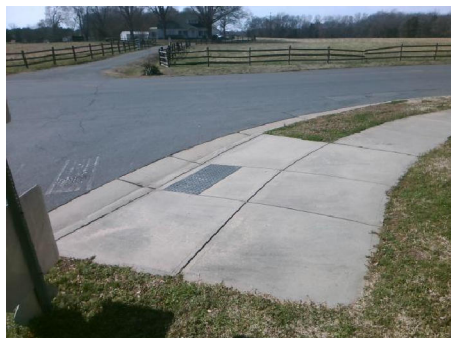
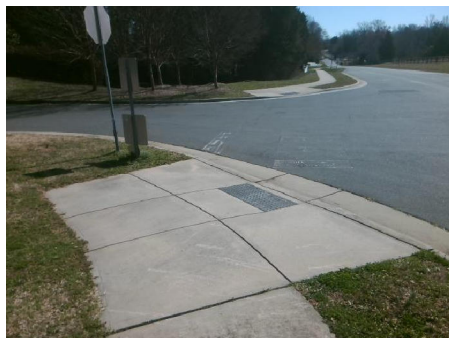
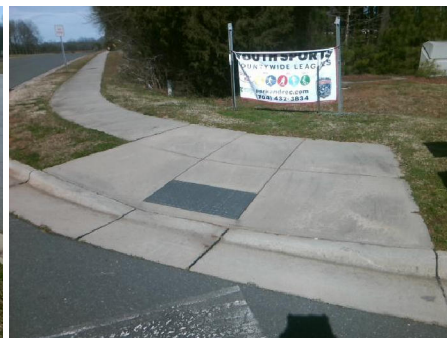
**Not Found, R304.5.1, R304.2.2,
R304.5.3**

Compliance	Description	Data	Compliance	Description	Data
N/A	Ramp Length (in)	58.0	No	Ramp Slope (%)	12.2
No	Ramp Width (in)	45.0	No	Ramp XSlope (%)	3.0
N/A	Flare Type LT	N/A	N/A	Flare Type RT	N/A
N/A	Flare Slope LT (%)	N/A	N/A	Flare Slope RT (%)	N/A
N/A	Flare Traversable LT?	N/A	N/A	Flare Traversable RT?	N/A
N/A	Landing Length (in)	N/A	N/A	DWS Provided?	N/A
N/A	Landing Width (in)	N/A	N/A	DWS Contrast?	N/A
N/A	Landing Slope (%)	N/A	N/A	DWS Length (in)	N/A
N/A	Landing X Slope (%)	N/A	N/A	DWS Full Width?	N/A
N/A	Landing Curb? (Y/N)	N/A	N/A	DWS Offset (in)	N/A
N/A	Shared Landing?	N/A			
N/A	Gutter Ponding?	N/A	N/A	Gutter Slope (%)	N/A
N/A	Gutter Lip Ht (in)	N/A	N/A	Gutter X Slope (%)	N/A
N/A	Painted X Walk1?	No	N/A	Painted X Walk2?	No
	X Walk 1 Direction	To SW		X Walk 2 Direction	To SE
N/A	X Walk 1 Width (in)	N/A	N/A	X Walk 2 Width (in)	N/A
	X Walk 1 Slope (%)	1.0		X Walk 2 Slope (%)	1.8
	X Walk 1 X Slope (%)	2.2		X Walk 2 X Slope (%)	1.9

N/A	Ramp inside XWalk1?	N/A	N/A	Ramp inside XWalk2?	N/A
	Road Slope (%)	3.3	N/A	Clear Space?	N/A
	Road X Slope (%)	0.3	N/A	Clear Space to XWalk (in)	N/A
N/A	Any Obstructions?	N/A	N/A	Storm Grate/Utility Hazard?	N/A
	Obstruction Type			Storm Grate/Utility Type	
		N/A			N/A
			Yes	Surface Condition? (G/P)	Good

Remove & Replace Curb Ramp With Two New Directional Ramps or Equivalent.
