# Access Compliance Report

## Public Rights-of-Way

### (Curb Ramps)

Intersection ID: 13981	Main Street: NORWICH_PL	Cross Street: WALTON_RD	Location: SW
ADA ID: 5AF91A8B1B10	Ramp Type: Perp	Initial Pass/Fail: Fail	Overall Compliance: No
		Severity Score: 12.5

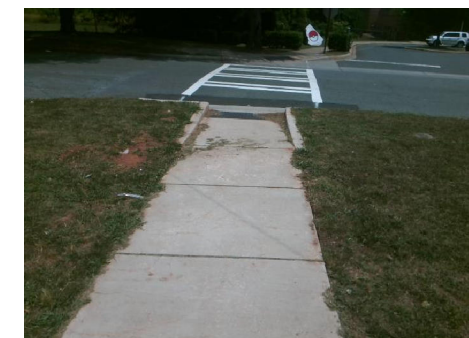
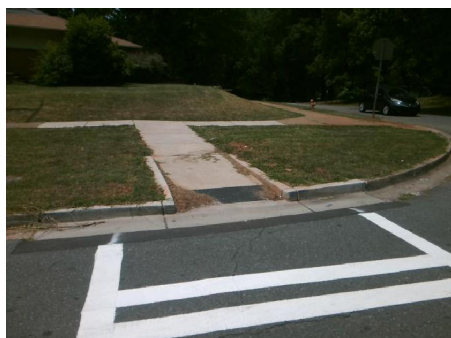
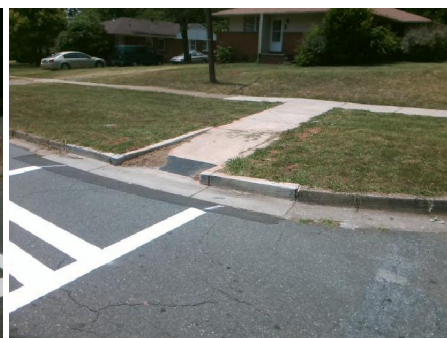
Compliance	Description	Data	Compliance	Description	Data
N/A	Ramp Length (in)	96.0	No	Ramp Slope (%)	9.3
Yes	Ramp Width (in)	59.0	Yes	Ramp XSlope (%)	1.4
N/A	Flare Type LT	N/A	N/A	Flare Type RT	N/A
N/A	Flare Slope LT (%)	N/A	N/A	Flare Slope RT (%)	N/A
N/A	Flare Traversable LT?	N/A	N/A	Flare Traversable RT?	N/A
N/A	Landing Length (in)	N/A	N/A	DWS Provided?	N/A
N/A	Landing Width (in)	N/A	N/A	DWS Contrast?	N/A
N/A	Landing Slope (%)	N/A	N/A	DWS Length (in)	N/A
N/A	Landing X Slope (%)	N/A	N/A	DWS Full Width?	N/A
N/A	Landing Curb? (Y/N)	N/A	N/A	DWS Offset (in)	N/A
N/A	Shared Landing?	N/A			
N/A	Gutter Ponding?	N/A	N/A	Gutter Slope (%)	N/A
N/A	Gutter Lip Ht (in)	N/A	N/A	Gutter X Slope (%)	N/A
N/A	Painted X Walk1?	Yes	N/A	Painted X Walk2?	N/A
	X Walk 1 Direction	To NE		X Walk 2 Direction	N/A
N/A	X Walk 1 Width (in)	108.0	N/A	X Walk 2 Width (in)	N/A
	X Walk 1 Slope (%)	2.3		X Walk 2 Slope (%)	N/A
	X Walk 1 X Slope (%)	4.4		X Walk 2 X Slope (%)	N/A

N/A	Ramp inside XWalk1?	Yes	N/A	Ramp inside XWalk2?	N/A
	Road Slope (%)	N/A	N/A	Clear Space?	N/A
	Road X Slope (%)	N/A	N/A	Clear Space to XWalk (in)	N/A
N/A	Any Obstructions?	N/A	N/A	Storm Grate/Utility Hazard?	N/A
	Obstruction Type			Storm Grate/Utility Type	
		N/A			N/A
		Yes		Surface Condition? (G/P)	Good

**Remove & Replace Entire Ramp.**

**R304.2.2**

**\$ 1850.00**
