Access Compliance Report

Public Rights-of-Way

(Curb Ramps)

Intersection ID: 10037734	Main Street: SHADY_REACH_LN	Cross Street: N/A	Location: N
ADA ID: 5AFDF462CC76	Ramp Type: Directional1	Initial Pass/Fail: Fail	Overall Compliance: No
Severity Score: 22.5			
Codes/Mitigation Info/Possible Solution		Field Measurements/Component Compliance

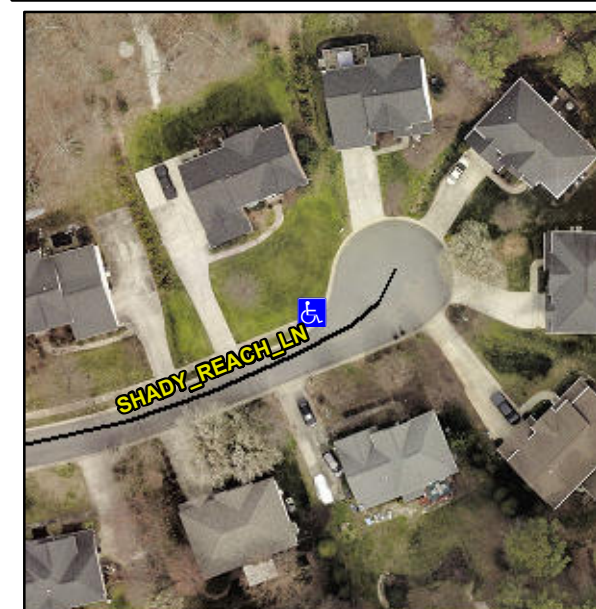
Compliance	Description	Data	Compliance	Description	Data
N/A	Ramp Length (in)	20.0	N/A	Grade Break?	N/A
No	Ramp Width (in)	47.0	N/A	Grade Break Slope (%)	0.0
No	Ramp Slope (%)	11.8	N/A	Grade Break XSlope (%)	0.0
No	Ramp XSlope (%)	4.6			
N/A	Flare Type LT	N/A	N/A	Flare Type RT	N/A
N/A	Flare Slope LT (%)	N/A	N/A	Flare Slope RT (%)	0.0
N/A	Flare Traversable LT?	N/A	N/A	Flare Traversable RT?	N/A
N/A	Landing Length (in)	0.0	N/A	DWS Provided?	N/A
N/A	Landing Width (in)	0.0	N/A	DWS Contrast?	N/A
N/A	Landing Slope (%)	0.0	N/A	DWS Length (in)	N/A
N/A	Landing X Slope (%)	0.0	N/A	DWS Full Width?	N/A
N/A	Landing Curb? (Y/N)	N/A	N/A	DWS Offset LT (in)	N/A
N/A	Shared Landing?	N/A	N/A	DWS Offset RT (in)	N/A
N/A	Gutter Ponding?	0.0	N/A	Gutter Slope (%)	N/A
N/A	Gutter Lip Ht (in)	0.0	N/A	Gutter X Slope (%)	N/A
N/A	Painted X Walk1?	No		Road Slope (%)	5.2
	X Walk 1 Direction	To E		Road X Slope (%)	3.5
	X Walk 1 Width (in)	N/A		Clear Space?	N/A

X Walk 1 Slope (%)	5.2	N/A	Clear Space to XWalk (in)	N/A
	X Walk 1 X Slope (%)	3.5	N/A	Storm Grate/Utility Hazard?	N/A
N/A	Ramp inside XWalk1?	N/A		Storm Grate/Utility Type	
N/A	Any Obstructions?	N/A			N/A
	Obstruction Type		Yes	Surface Condition? (G/P)	Good
			N/A	Curb Slope (%)	5.9

Possible Solutions:

Remove & Replace Entire Ramp.

R304.5.1, R304.2.2, R304.5.3
