## Access Compliance Report Public Rights-of-Way (Curb Ramps)

Intersection ID: 10040592 Main Street: W\_ARROWOOD\_RD Cross Street: N/A Location: NW

ADA ID: 5B015FC22F10 Ramp Type: Perp Initial Pass/Fail: Pass Overall Compliance: No Severity Score: 7.5

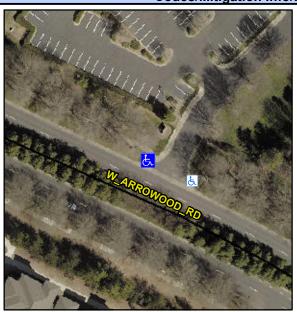
Not Found, R304.2.3, R305.2,
R304.5.4

Field Measurements/Component Compliance						
Comp	liance Description	Data	Comp	liance Description	Data	
N/A	Ramp Length (in)	46.0	Yes	Ramp Slope (%)	7.9	
Yes	Ramp Width (in)	49.0	Yes	Ramp XSlope (%)	1.6	
N/A	Flare Type LT	Sloped	N/A	Flare Type RT	N/A	
N/A	Flare Slope LT (%)	3.9	No	Flare Slope RT (%)	10.6	
N/A	Flare Traversable LT?	No	N/A	Flare Traversable RT?	Yes	
Yes	Landing Length (in)	82.0	Yes	DWS Provided?	Yes	
Yes	Landing Width (in)	48.0	Yes	DWS Contrast?	Yes	
Yes	Landing Slope (%)	0.8	Yes	DWS Length (in)	24.0	
Yes	Landing X Slope (%)	3.3	Yes	DWS Full Width?	Yes	
N/A	Landing Curb? (Y/N)	No	No	DWS Offset (in)	2.5	
N/A	Shared Landing?	No				
Yes	Gutter Ponding?	No	No	Gutter Slope (%)	6.7	
Yes	Gutter Lip Ht (in)	0.0	Yes	Gutter X Slope (%)	3.5	
N/A	Painted X Walk1?	No	N/A	Painted X Walk2?	N/A	
	X Walk 1 Direction	To SE		X Walk 2 Direction	N/A	
N/A	X Walk 1 Width (in)	N/A	N/A	X Walk 2 Width (in)	N/A	
	X Walk 1 Slope (%)	0.5		X Walk 2 Slope (%)	N/A

X Walk 1 X Slope (%)	8.0		X Walk 2 X Slope (%)	N/A	
N/A	Ramp inside XWalk1?	N/A	N/A	Ramp inside XWalk2?	N/A	
	Road Slope (%)	N/A	N/A	Clear Space?	Yes	
	Road X Slope (%)	N/A	N/A	Clear Space to XWalk (in)	N/A	
Yes	Any Obstructions?	No	Yes	Storm Grate/Utility Hazard?	No	
	Obstruction Type			Storm Grate/Utility Type		
		N/A			N/A	
			Yes	Surface Condition? (G/P)	Good

Remove & Replace Entire Ramp.
Remove & Replace Gutter.
