# Access Compliance Report

## Public Rights-of-Way

### (Curb Ramps)

Intersection ID: 15070	Main Street: IDEAL_WY	Cross Street: REMOUNT_RD	Location: W
ADA ID: 5B01FE33905B	Ramp Type: Perp	Initial Pass/Fail: Fail	Overall Compliance: No
		Severity Score: 25

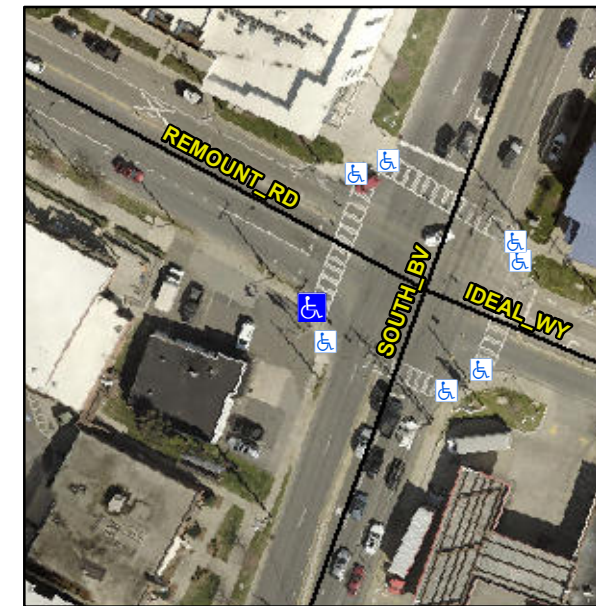
**Not Found, R304.2.2, R304.5.3**

Compliance	Description	Data	Compliance	Description	Data
N/A	Ramp Length (in)	71.0	No	Ramp Slope (%)	8.5
Yes	Ramp Width (in)	48.0	No	Ramp XSlope (%)	5.7
N/A	Flare Type LT	N/A	N/A	Flare Type RT	N/A
N/A	Flare Slope LT (%)	N/A	N/A	Flare Slope RT (%)	N/A
N/A	Flare Traversable LT?	N/A	N/A	Flare Traversable RT?	N/A
N/A	Landing Length (in)	N/A	N/A	DWS Provided?	N/A
N/A	Landing Width (in)	N/A	N/A	DWS Contrast?	N/A
N/A	Landing Slope (%)	N/A	N/A	DWS Length (in)	N/A
N/A	Landing X Slope (%)	N/A	N/A	DWS Full Width?	N/A
N/A	Landing Curb? (Y/N)	N/A	N/A	DWS Offset (in)	N/A
N/A	Shared Landing?	N/A			
N/A	Gutter Ponding?	N/A	N/A	Gutter Slope (%)	N/A
N/A	Gutter Lip Ht (in)	N/A	N/A	Gutter X Slope (%)	N/A
N/A	Painted X Walk1?	Yes	N/A	Painted X Walk2?	N/A
	X Walk 1 Direction	To NE		X Walk 2 Direction	N/A
N/A	X Walk 1 Width (in)	109.0	N/A	X Walk 2 Width (in)	N/A
	X Walk 1 Slope (%)	7.1		X Walk 2 Slope (%)	N/A
	X Walk 1 X Slope (%)	2.7		X Walk 2 X Slope (%)	N/A

N/A	Ramp inside XWalk1?	Yes	N/A	Ramp inside XWalk2?	N/A
	Road Slope (%)	N/A	N/A	Clear Space?	N/A
	Road X Slope (%)	N/A	N/A	Clear Space to XWalk (in)	N/A
N/A	Any Obstructions?	N/A	N/A	Storm Grate/Utility Hazard?	N/A
	Obstruction Type			Storm Grate/Utility Type	
		N/A			N/A
		Yes		Surface Condition? (G/P)	Good

**Remove & Replace Entire Ramp.**

Total Cost: \$ 1850.00
