Access Compliance Report Public Rights-of-Way (Curb Ramps)

Intersection ID: 20314 Main Street: COLONY_RD Cross Street: MORROCROFT_FARMS_LN Location: E

ADA ID: 5B04A8CDC21D Ramp Type: Directional1 Initial Pass/Fail: Fail Overall Compliance: No Severity Score: 37.5

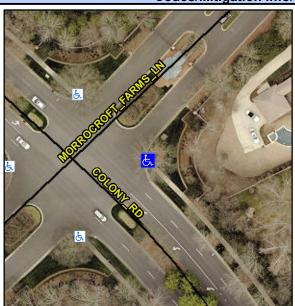
Field Measurements/Component Compliance								
Compl	iance Description	Data	Compl	iance Description	Data			
N/A	Ramp Length (in)	62.0	N/A	Grade Break?	N/A			
Yes	Ramp Width (in)	60.0	N/A	Grade Break Slope (%)	0.0			
No	Ramp Slope (%)	9.2	N/A	Grade Break XSlope (%)	0.0			
No	Ramp XSlope (%)	7.9						
N/A	Flare Type LT	N/A	N/A	Flare Type RT	N/A			
N/A	Flare Slope LT (%)	N/A	N/A	Flare Slope RT (%)	0.0			
N/A	Flare Traversable LT?	N/A	N/A	Flare Traversable RT?	N/A			
N/A	Landing Length (in)	0.0	N/A	DWS Provided?	N/A			
N/A	Landing Width (in)	0.0	N/A	DWS Contrast?	N/A			
N/A	Landing Slope (%)	0.0	N/A	DWS Length (in)	N/A			
N/A	Landing X Slope (%)	0.0	N/A	DWS Full Width?	N/A			
N/A	Landing Curb? (Y/N)	N/A	N/A	DWS Offset LT (in)	N/A			
N/A	Shared Landing?	N/A	N/A	DWS Offset RT (in)	N/A			
N/A	Gutter Ponding?	0.0	N/A	Gutter Slope (%)	N/A			
N/A	Gutter Lip Ht (in)	0.0	N/A	Gutter X Slope (%)	N/A			
N/A	Painted X Walk1?	No		Road Slope (%)	1.1

Possible Solution		
Possible Solutions:	Co	
Remove & Replace Entire Ramp.		
•	Yes	
	No	
	No	
	N/A	
	N/A	
Surveyor Notes:	N/A	
N/A	N/A	
	N/A	
	N/A	
	N/A	
PROW/ADA:	N/A	
R304.2.2, R304.5.3	N/A
