Access Compliance Report

Public Rights-of-Way

(Curb Ramps)

Intersection ID: 10038746	Main Street: STATE_ST	Cross Street: N/A	Location: S
ADA ID: 5B1574F9B981	Ramp Type: BlendTrans2	Initial Pass/Fail: Fail	Overall Compliance: No
		Severity Score: 12.5

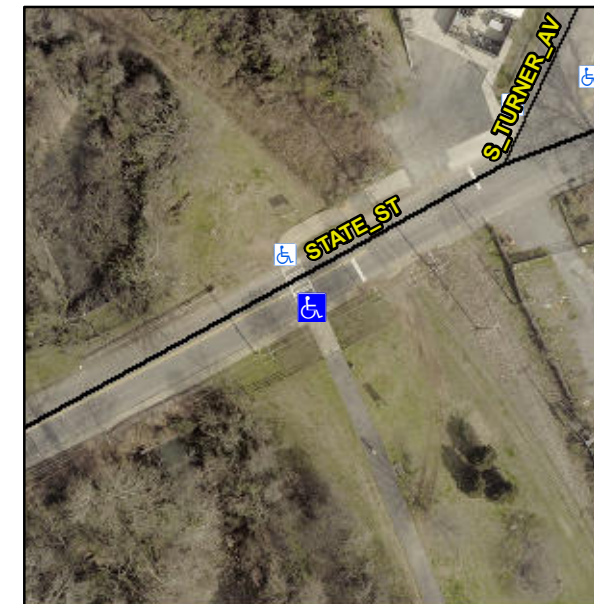
Compliance	Description	Data	Compliance	Description	Data
N/A	Ramp Length (in)	54.0	Yes	BlendTrans Slope (%)	0.0
Yes	Ramp Width (in)	125.0	No	BlendTrans XSlope (%)	6.0
N/A	Flare Type LT	N/A	N/A	Flare Type RT	N/A
N/A	Flare Slope LT (%)	N/A	N/A	Flare Slope RT (%)	N/A
N/A	Flare Traversable LT?	N/A	N/A	Flare Traversable RT?	N/A
N/A	Landing Length (in)	N/A	N/A	DWS Provided?	N/A
N/A	Landing Width (in)	N/A	N/A	DWS Contrast?	N/A
N/A	Landing Slope (%)	N/A	N/A	DWS Length (in)	N/A
N/A	Landing X Slope (%)	N/A	N/A	DWS Full Width?	N/A
N/A	Landing Curb? (Y/N)	N/A	N/A	DWS Offset (in)	N/A
N/A	Shared Landing?	N/A			
N/A	Gutter Ponding?	N/A	N/A	Gutter Slope (%)	N/A
N/A	Gutter Lip Ht (in)	0.5	N/A	Gutter X Slope (%)	N/A
N/A	Painted X Walk1?	Yes	N/A	Painted X Walk2?	N/A
	X Walk 1 Direction	To NW		X Walk 2 Direction	N/A
	X Walk 1 Width (in)	116.0		X Walk 2 Width (in)	N/A
	X Walk 1 Slope (%)	3.5		X Walk 2 Slope (%)	N/A
	X Walk 1 X Slope (%)	5.7		X Walk 2 X Slope (%)	N/A

N/A	Ramp inside XWalk1?	Yes	N/A	Ramp inside XWalk2?	N/A
	Road Slope (%)	5.7		Clear Space?	N/A
	Road X Slope (%)	3.5	N/A	Clear Space to XWalk (in)	N/A
N/A	Any Obstructions?	N/A	N/A	Storm Grate/Utility Hazard?	N/A
	Obstruction Type			Storm Grate/Utility Type	
		N/A			N/A
			Yes	Surface Condition? (G/P)	Good
			N/A	Curb Slope (%)	N/A

Remove & Replace Curb Ramp With Two New Directional Ramps or Equivalent.

R304.5.3

\$ 3200.00
