Access Compliance Report

Public Rights-of-Way

(Curb Ramps)

Intersection ID: 51370	Main Street: UNIVERSITY_POINTE_BV	Cross Street: IKEA_BV	Location: W
ADA ID: 5B1F766886A5	Ramp Type: Perp	Initial Pass/Fail: Pass	Overall Compliance: No
Severity Score: 0			
Codes/Mitigation Info/Possible Solution		Field Measurements/Component Compliance

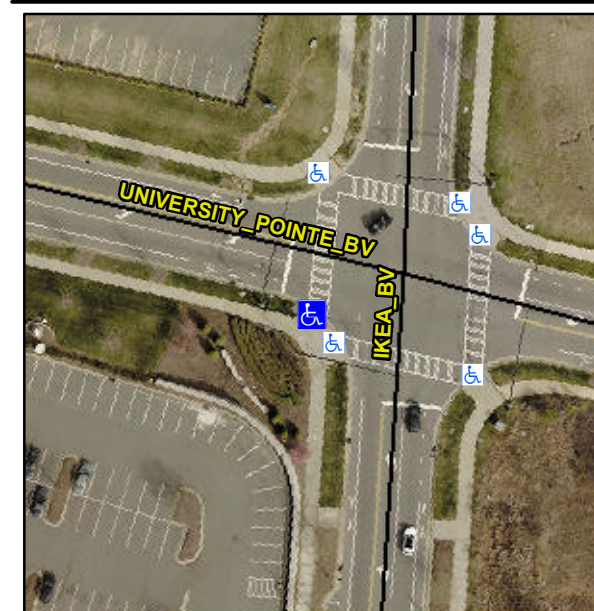
Not Found, R304.2.2-Perp, R304.3.2-Para

Compliance	Description	Data	Compliance	Description	Data
N/A	Ramp Length (in)	101.0	Yes	Ramp Slope (%)	5.2
Yes	Ramp Width (in)	57.0	Yes	Ramp XSlope (%)	1.5
N/A	Flare Type LT	Sloped	N/A	Flare Type RT	N/A
N/A	Flare Slope LT (%)	8.0	N/A	Flare Slope RT (%)	11.8
N/A	Flare Traversable LT?	Yes	N/A	Flare Traversable RT?	No
Yes	Landing Length (in)	101.0	Yes	DWS Provided?	Yes
Yes	Landing Width (in)	57.0	Yes	DWS Contrast?	Yes
No	Landing Slope (%)	3.3	Yes	DWS Length (in)	24.0
Yes	Landing X Slope (%)	1.5	Yes	DWS Full Width?	Yes
N/A	Landing Curb? (Y/N)	No	Yes	DWS Offset (in)	1.8
N/A	Shared Landing?	No			
Yes	Gutter Ponding?	No	Yes	Gutter Slope (%)	2.3
Yes	Gutter Lip Ht (in)	0.0	Yes	Gutter X Slope (%)	1.0
N/A	Painted X Walk1?	Yes	N/A	Painted X Walk2?	N/A
	X Walk 1 Direction	To N		X Walk 2 Direction	N/A
N/A	X Walk 1 Width (in)	112.0	N/A	X Walk 2 Width (in)	N/A
	X Walk 1 Slope (%)	5.0		X Walk 2 Slope (%)	N/A
	X Walk 1 X Slope (%)	4.7		X Walk 2 X Slope (%)	N/A

Yes	Ramp inside XWalk1?	Yes	N/A	Ramp inside XWalk2?	N/A
	Road Slope (%)	N/A	N/A	Clear Space?	Yes
	Road X Slope (%)	N/A	N/A	Clear Space to XWalk (in)	N/A
Yes	Any Obstructions?	No	Yes	Storm Grate/Utility Hazard?	No
	Obstruction Type			Storm Grate/Utility Type	
			N/A		N/A
			Yes	Surface Condition? (G/P)	Good

Possible Solutions:

Remove & Replace Entire Ramp.
