# Access Compliance Report

## Public Rights-of-Way

| Intersection ID: 11144 | Main Street: CLEMSON_AV | Cross Street: WOODSIDE_AV | Location: NW |
| ADA ID: 5B23DC5B3529 | Ramp Type: Perp | Initial Pass/Fail: Fail | Overall Compliance: No |

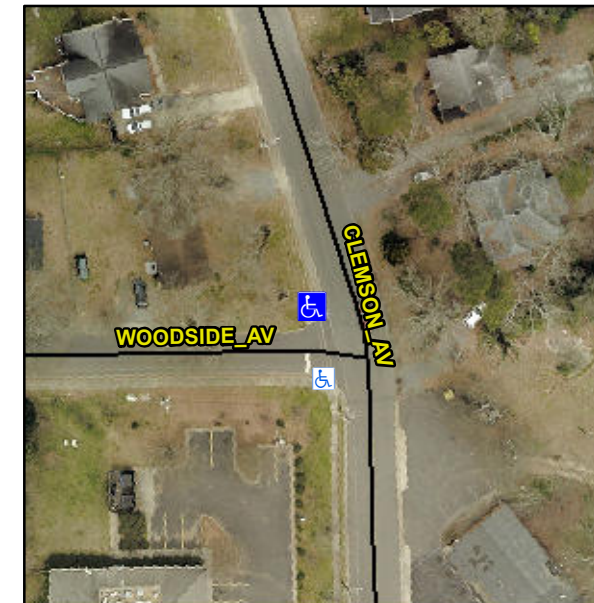
| | | Severity Score: 12.5 | |

**Not Found, R304.2.2**

| Compliance | Description | Data | Compliance | Description | Data |
|---|---|---|---|---|---|
| N/A | Ramp Length (in) | 38.0 | No | Ramp Slope (%) | 9.0 |

**Remove & Replace Entire Ramp.**

Total Cost: \$ 1850.00
