Access Compliance Report

Public Rights-of-Way

(Curb Ramps)

Intersection ID: 12027	Main Street: S_SUMMIT_AV	Cross Street: W_MOREHEAD_ST	Location: SW
ADA ID: 5B39F287E568	Ramp Type: Perp	Initial Pass/Fail: Fail	Overall Compliance: No
		Severity Score: 8.75

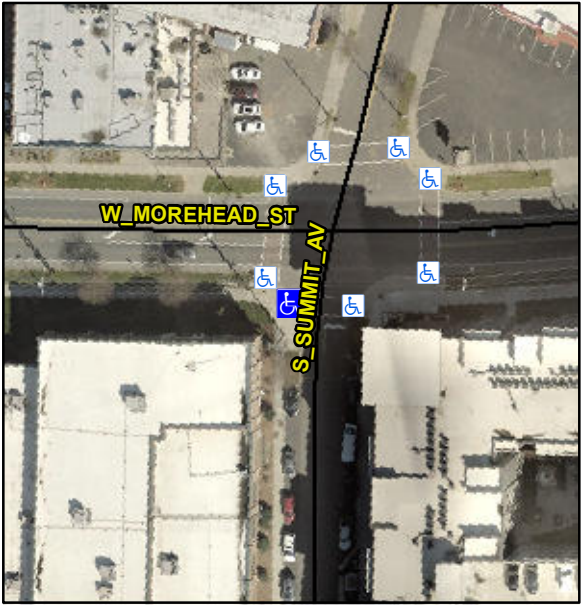
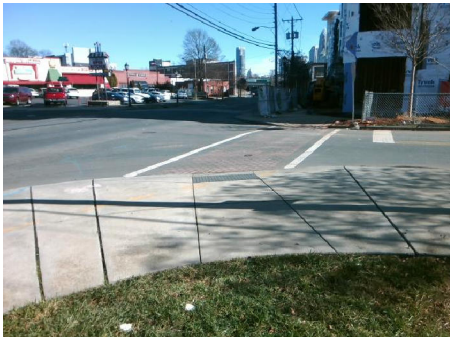
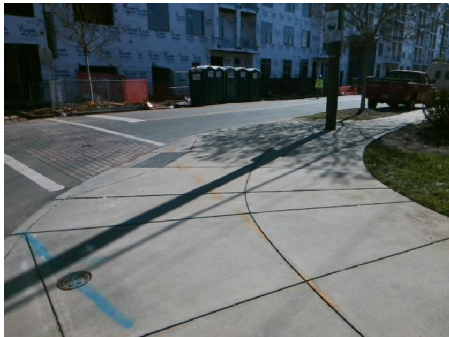
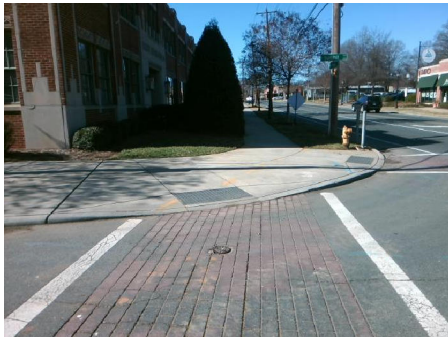
Compliance	Description	Data	Compliance	Description	Data
N/A	Ramp Length (in)	89.5	Yes	Ramp Slope (%)	7.2
No	Ramp Width (in)	47.5	Yes	Ramp XSlope (%)	1.0
N/A	Flare Type LT	N/A	N/A	Flare Type RT	N/A
N/A	Flare Slope LT (%)	N/A	N/A	Flare Slope RT (%)	N/A
N/A	Flare Traversable LT?	N/A	N/A	Flare Traversable RT?	N/A
N/A	Landing Length (in)	N/A	N/A	DWS Provided?	N/A
N/A	Landing Width (in)	N/A	N/A	DWS Contrast?	N/A
N/A	Landing Slope (%)	N/A	N/A	DWS Length (in)	N/A
N/A	Landing X Slope (%)	N/A	N/A	DWS Full Width?	N/A
N/A	Landing Curb? (Y/N)	N/A	N/A	DWS Offset (in)	N/A
N/A	Shared Landing?	N/A			
N/A	Gutter Ponding?	N/A	N/A	Gutter Slope (%)	N/A
N/A	Gutter Lip Ht (in)	N/A	N/A	Gutter X Slope (%)	N/A
N/A	Painted X Walk1?	Yes	N/A	Painted X Walk2?	N/A
	X Walk 1 Direction	To E		X Walk 2 Direction	N/A
N/A	X Walk 1 Width (in)	104.0	N/A	X Walk 2 Width (in)	N/A
	X Walk 1 Slope (%)	2.9		X Walk 2 Slope (%)	N/A
	X Walk 1 X Slope (%)	0.5		X Walk 2 X Slope (%)	N/A

N/A	Ramp inside XWalk1?	Yes	N/A	Ramp inside XWalk2?	N/A
	Road Slope (%)	N/A	N/A	Clear Space?	N/A
	Road X Slope (%)	N/A	N/A	Clear Space to XWalk (in)	N/A
N/A	Any Obstructions?	N/A	N/A	Storm Grate/Utility Hazard?	N/A
	Obstruction Type			Storm Grate/Utility Type	
			N/A		N/A
			Yes	Surface Condition? (G/P)	Good

Possible Solutions:				
	Remove & Replace Entire Ramp.				
	Surveyor Notes:				
	N/A				
	PROW/ADA:				
	R304.5.1				
Street 1 Name	SUMMIT AV				
Stop Condition-Street 2	StopSign				
Street 2 Name	N/A				
Stop Condition-Street 1	N/A				
Total Cost:		\$	1850.00
