Access Compliance Report

Public Rights-of-Way

(Curb Ramps)

Intersection ID: 25678	Main Street: CARMEL_EXECUTIVE_PARK	Cross Street: CARMEL_RD	Location: W
ADA ID: 5B3A5131987D	Ramp Type: IslandPerp	Initial Pass/Fail: Fail	Overall Compliance: No
Severity Score: 17.5			
Codes/Mitigation Info/Possible Solution		Field Measurements/Component Compliance

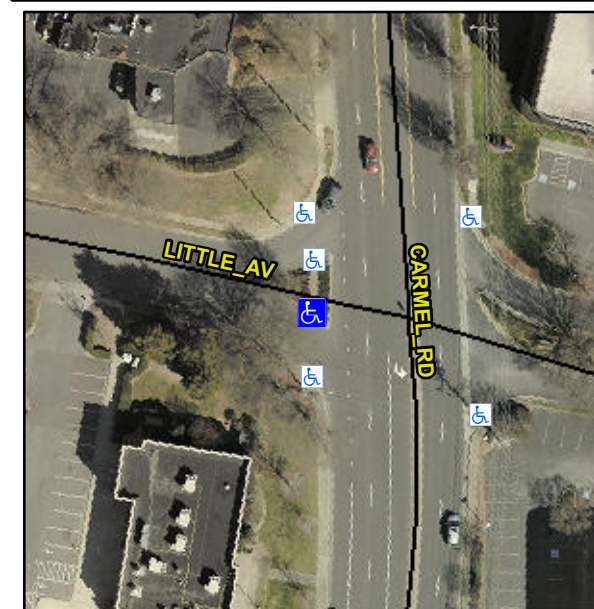
Not Found, R304.5.1

Compliance	Description	Data	Compliance	Description	Data
N/A	Ramp Length (in)	60.0	Yes	Ramp Slope (%)	5.7
No	Ramp Width (in)	32.0	Yes	Ramp XSlope (%)	0.3
N/A	Flare Type LT	N/A	N/A	Flare Type RT	N/A
N/A	Flare Slope LT (%)	N/A	N/A	Flare Slope RT (%)	N/A
N/A	Flare Traversable LT?	N/A	N/A	Flare Traversable RT?	N/A
N/A	Landing Length (in)	N/A	N/A	DWS Provided?	N/A
N/A	Landing Width (in)	N/A	N/A	DWS Contrast?	N/A
N/A	Landing Slope (%)	N/A	N/A	DWS Length (in)	N/A
N/A	Landing X Slope (%)	N/A	N/A	DWS Full Width?	N/A
N/A	Landing Curb? (Y/N)	N/A	N/A	DWS Offset (in)	N/A
N/A	Shared Landing?	N/A			
N/A	Gutter Ponding?	N/A	N/A	Gutter Slope (%)	N/A
N/A	Gutter Lip Ht (in)	N/A	N/A	Gutter X Slope (%)	N/A
N/A	Painted X Walk1?	No	N/A	Painted X Walk2?	N/A
	X Walk 1 Direction	To S		X Walk 2 Direction	N/A
N/A	X Walk 1 Width (in)	N/A	N/A	X Walk 2 Width (in)	N/A
	X Walk 1 Slope (%)	1.9		X Walk 2 Slope (%)	N/A
	X Walk 1 X Slope (%)	0.7		X Walk 2 X Slope (%)	N/A

N/A	Ramp inside XWalk1?	N/A	N/A	Ramp inside XWalk2?	N/A
	Road Slope (%)	N/A	N/A	Clear Space?	N/A
	Road X Slope (%)	N/A	N/A	Clear Space to XWalk (in)	N/A
N/A	Any Obstructions?	N/A	N/A	Storm Grate/Utility Hazard?	N/A
	Obstruction Type			Storm Grate/Utility Type	
		N/A			N/A
			Yes	Surface Condition? (G/P)	Good

Possible Solutions:

Remove & Replace Entire Ramp.
