# Access Compliance Report

## Public Rights-of-Way

### (Curb Ramps)

Intersection ID: N/A	Main Street: BREVARD_ST	Cross Street: STONEWALL_ST	Location: N
ADA ID: 5B44B320911F	Ramp Type: BlendTrans1	Initial Pass/Fail: Fail	Overall Compliance: No
Severity Score: 12.5			
Codes/Mitigation Info/Possible Solution		Field Measurements/Component Compliance

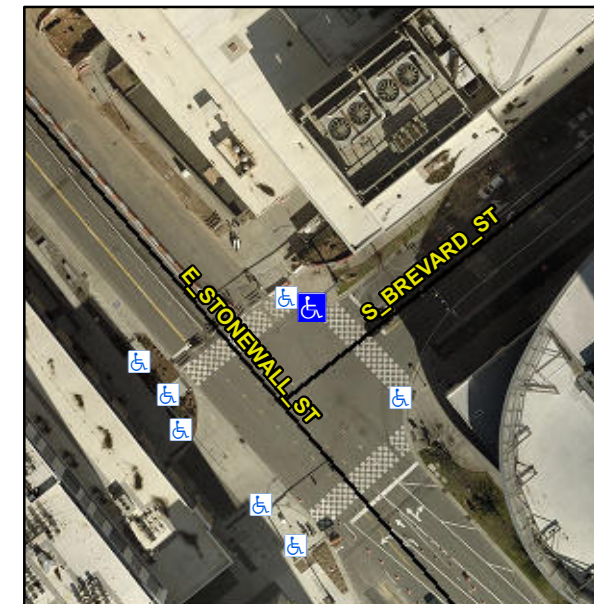
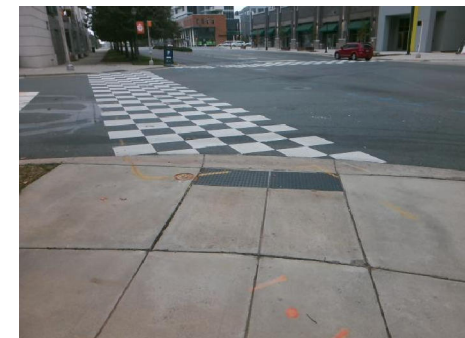
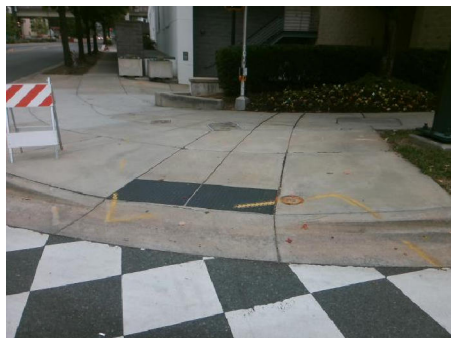
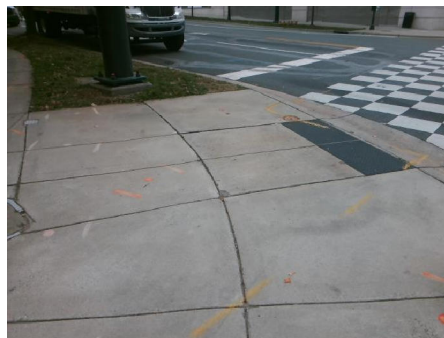
**Not Found, R304.5.3**

Compliance	Description	Data	Compliance	Description	Data
N/A	Ramp Length (in)	83.0	Yes	BlendTrans Slope (%)	2.0
Yes	Ramp Width (in)	67.0	No	BlendTrans XSlope (%)	5.1
N/A	Flare Type LT	N/A	N/A	Flare Type RT	N/A
N/A	Flare Slope LT (%)	N/A	N/A	Flare Slope RT (%)	N/A
N/A	Flare Traversable LT?	N/A	N/A	Flare Traversable RT?	N/A
N/A	Landing Length (in)	N/A	N/A	DWS Provided?	N/A
N/A	Landing Width (in)	N/A	N/A	DWS Contrast?	N/A
N/A	Landing Slope (%)	N/A	N/A	DWS Length (in)	N/A
N/A	Landing X Slope (%)	N/A	N/A	DWS Full Width?	N/A
N/A	Landing Curb? (Y/N)	N/A	N/A	DWS Offset (in)	N/A
N/A	Shared Landing?	N/A			
N/A	Gutter Ponding?	N/A	N/A	Gutter Slope (%)	N/A
N/A	Gutter Lip Ht (in)	N/A	N/A	Gutter X Slope (%)	N/A
N/A	Painted X Walk1?	Yes	N/A	Painted X Walk2?	N/A
	X Walk 1 Direction	To SE		X Walk 2 Direction	N/A
	X Walk 1 Width (in)	144.0		X Walk 2 Width (in)	N/A
	X Walk 1 Slope (%)	0.6		X Walk 2 Slope (%)	N/A
	X Walk 1 X Slope (%)	4.3		X Walk 2 X Slope (%)	N/A

N/A	Ramp inside XWalk1?	Yes	N/A	Ramp inside XWalk2?	N/A
	Road Slope (%)	4.3		Clear Space?	N/A
	Road X Slope (%)	0.6	N/A	Clear Space to XWalk (in)	N/A
N/A	Any Obstructions?	N/A	N/A	Storm Grate/Utility Hazard?	N/A
	Obstruction Type			Storm Grate/Utility Type	
		N/A			N/A
			Yes	Surface Condition? (G/P)	Good
			No	Curb Slope (%)	15.2

**Remove & Replace Curb Ramp With Two New Directional Ramps or Equivalent.**
