Access Compliance Report

Public Rights-of-Way

(Curb Ramps)

Intersection ID: 10011488	Main Street: SHAMROCK_DR	Cross Street: N/A	Location: NE
ADA ID: 5B4947BD27DD	Ramp Type: PerpDiag	Initial Pass/Fail: Fail	Overall Compliance: No
Severity Score: 33.75			
Codes/Mitigation Info/Possible Solution		Field Measurements/Component Compliance

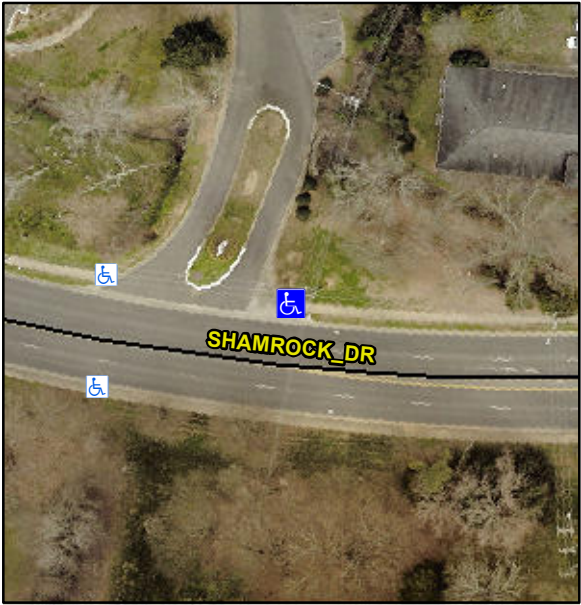
PROW/ADA:						
	Not Found, R304.5.1, R304.2.2						
Street 1 Name	ENTRANCE	Compliance	Description	Data	Compliance	Description	Data
Stop Condition-Street 2	None	N/A	Ramp Length (in)	62.0	No	Ramp Slope (%)	12.1
Street 2 Name	SHAMROCK DR	No	Ramp Width (in)	41.0	Yes	Ramp XSlope (%)	1.5
Stop Condition-Street 1	None	N/A	Flare Type LT	N/A	N/A	Flare Type RT	N/A
		N/A	Flare Slope LT (%)	N/A	N/A	Flare Slope RT (%)	N/A
		N/A	Flare Traversable LT?	No	N/A	Flare Traversable RT?	No
		N/A	Landing Length (in)	N/A	N/A	DWS Provided?	N/A
		N/A	Landing Width (in)	N/A	N/A	DWS Contrast?	N/A
		N/A	Landing Slope (%)	N/A	N/A	DWS Length (in)	N/A
		N/A	Landing X Slope (%)	N/A	N/A	DWS Full Width?	N/A
		N/A	Landing Curb? (Y/N)	N/A	N/A	DWS Offset (in)	N/A
		N/A	Shared Landing?	N/A			
		N/A	Gutter Ponding?	N/A	N/A	Gutter Slope (%)	N/A

N/A	Gutter Lip Ht (in)	N/A	N/A	Gutter X Slope (%)	N/A
		N/A	Painted X Walk1?	No	N/A	Painted X Walk2?	No
			X Walk 1 Direction	To NW		X Walk 2 Direction	To S
		N/A	X Walk 1 Width (in)	N/A	N/A	X Walk 2 Width (in)	N/A
			X Walk 1 Slope (%)	1.0		X Walk 2 Slope (%)	2.0
			X Walk 1 X Slope (%)	1.1		X Walk 2 X Slope (%)	0.8
		N/A	Ramp inside XWalk1?	N/A	N/A	Ramp inside XWalk2?	N/A
			Road Slope (%)	1.4	N/A	Clear Space?	N/A
			Road X Slope (%)	0.7	N/A	Clear Space to XWalk (in)	N/A
		N/A	Any Obstructions?	N/A	N/A	Storm Grate/Utility Hazard?	N/A
			Obstruction Type			Storm Grate/Utility Type	
					N/A		N/A
					Yes	Surface Condition? (G/P)	Good
Total Cost:		\$ 3200.00

Possible Solutions:						
	Remove & Replace Curb Ramp With Two New Directional Ramps or Equivalent.
