Access Compliance Report

Public Rights-of-Way

(Curb Ramps)

Intersection ID: 29142	Main Street: APPLIEDALE_DR	Cross Street: BRIDGEVILLE_LN	Location:	N
ADA ID: 5B556845121D	Ramp Type: PerpDiag	Initial Pass/Fail: Fail	Overall Compliance: No	Severity Score: 21.25
Codes/Mitigation Info/Possible Solution		Field Measurements/Component Compliance

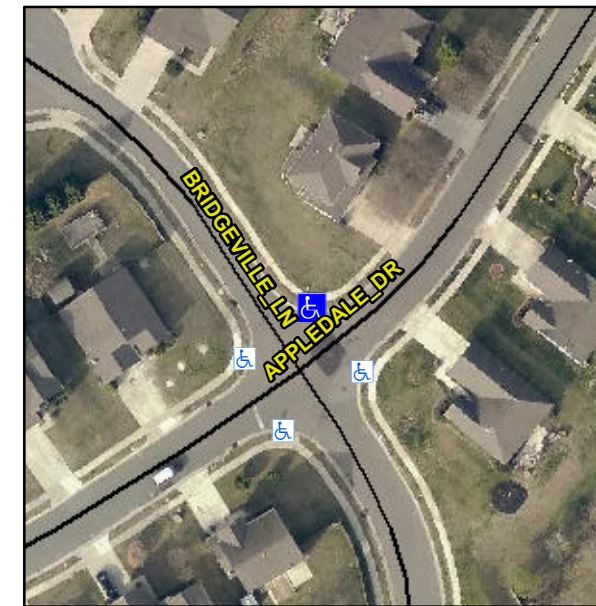
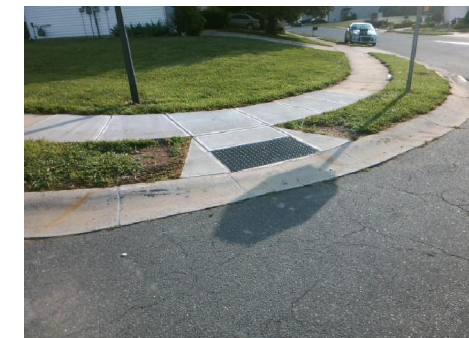
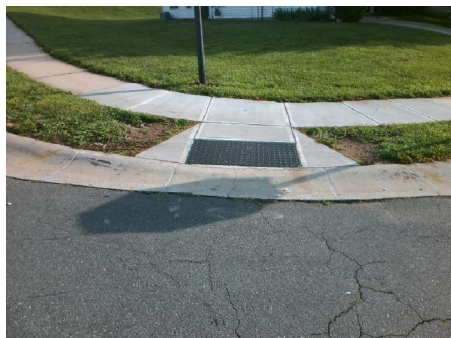
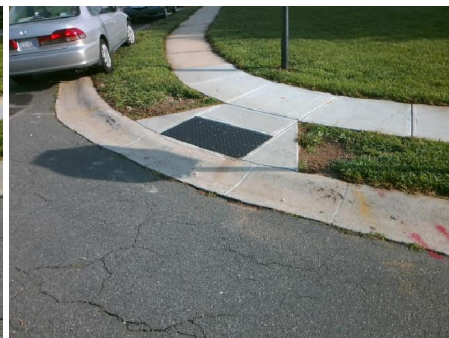
Not Found, R304.5.1, R304.5.3

Compliance	Description	Data	Compliance	Description	Data
N/A	Ramp Length (in)	47.0	Yes	Ramp Slope (%)	7.7
No	Ramp Width (in)	47.0	No	Ramp XSlope (%)	5.4
N/A	Flare Type LT	N/A	N/A	Flare Type RT	N/A
N/A	Flare Slope LT (%)	N/A	N/A	Flare Slope RT (%)	N/A
N/A	Flare Traversable LT?	N/A	N/A	Flare Traversable RT?	N/A
N/A	Landing Length (in)	N/A	N/A	DWS Provided?	N/A
N/A	Landing Width (in)	N/A	N/A	DWS Contrast?	N/A
N/A	Landing Slope (%)	N/A	N/A	DWS Length (in)	N/A
N/A	Landing X Slope (%)	N/A	N/A	DWS Full Width?	N/A
N/A	Landing Curb? (Y/N)	N/A	N/A	DWS Offset (in)	N/A
N/A	Shared Landing?	N/A			
N/A	Gutter Ponding?	N/A	N/A	Gutter Slope (%)	N/A
N/A	Gutter Lip Ht (in)	N/A	N/A	Gutter X Slope (%)	N/A
N/A	Painted X Walk1?	No	N/A	Painted X Walk2?	No
	X Walk 1 Direction	To W		X Walk 2 Direction	To S
N/A	X Walk 1 Width (in)	N/A	N/A	X Walk 2 Width (in)	N/A
	X Walk 1 Slope (%)	5.1		X Walk 2 Slope (%)	1.5
	X Walk 1 X Slope (%)	1.4		X Walk 2 X Slope (%)	6.4

N/A	Ramp inside XWalk1?	N/A	N/A	Ramp inside XWalk2?	N/A
	Road Slope (%)	5.9	N/A	Clear Space?	N/A
	Road X Slope (%)	0.8	N/A	Clear Space to XWalk (in)	N/A
N/A	Any Obstructions?	N/A	N/A	Storm Grate/Utility Hazard?	N/A
	Obstruction Type			Storm Grate/Utility Type	
		N/A			N/A
			Yes	Surface Condition? (G/P)	Good

Remove & Replace Curb Ramp With Two New Directional Ramps or Equivalent.
