# Access Compliance Report

## Public Rights-of-Way

### (Curb Ramps)

Intersection ID: 9018	Main Street: GRANT_ST	Cross Street: LAKEWOOD_AV	Location: S
ADA ID: 5B580F24EBFF	Ramp Type: Perp	Initial Pass/Fail: Fail	Overall Compliance: No
Severity Score: 60			
Codes/Mitigation Info/Possible Solution		Field Measurements/Component Compliance

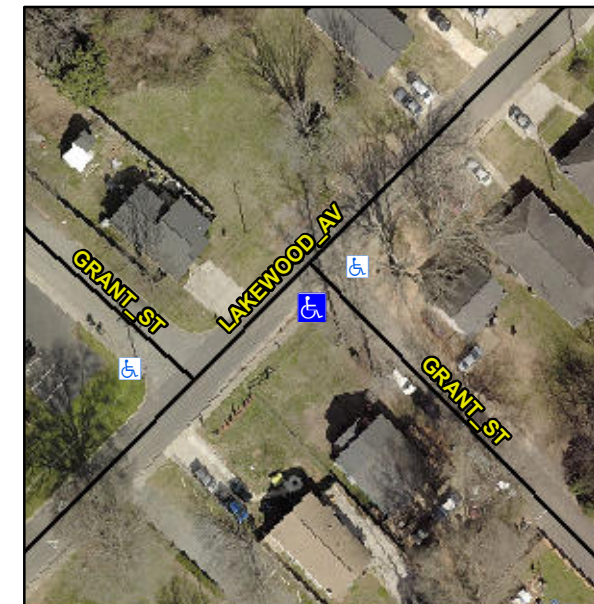
Compliance	Description	Data	Compliance	Description	Data
N/A	Ramp Length (in)	53.0	No	Ramp Slope (%)	12.2
No	Ramp Width (in)	27.0	Yes	Ramp XSlope (%)	0.1
N/A	Flare Type LT	N/A	N/A	Flare Type RT	N/A
N/A	Flare Slope LT (%)	N/A	N/A	Flare Slope RT (%)	N/A
N/A	Flare Traversable LT?	N/A	N/A	Flare Traversable RT?	N/A
N/A	Landing Length (in)	N/A	N/A	DWS Provided?	N/A
N/A	Landing Width (in)	N/A	N/A	DWS Contrast?	N/A
N/A	Landing Slope (%)	N/A	N/A	DWS Length (in)	N/A
N/A	Landing X Slope (%)	N/A	N/A	DWS Full Width?	N/A
N/A	Landing Curb? (Y/N)	N/A	N/A	DWS Offset (in)	N/A
N/A	Shared Landing?	N/A			
N/A	Gutter Ponding?	Yes	N/A	Gutter Slope (%)	N/A
N/A	Gutter Lip Ht (in)	N/A	N/A	Gutter X Slope (%)	N/A
N/A	Painted X Walk1?	No	N/A	Painted X Walk2?	N/A
	X Walk 1 Direction	To NE		X Walk 2 Direction	N/A
N/A	X Walk 1 Width (in)	N/A	N/A	X Walk 2 Width (in)	N/A
	X Walk 1 Slope (%)	3.7		X Walk 2 Slope (%)	N/A
	X Walk 1 X Slope (%)	1.2		X Walk 2 X Slope (%)	N/A

N/A	Ramp inside XWalk1?	N/A	N/A	Ramp inside XWalk2?	N/A
	Road Slope (%)	N/A	N/A	Clear Space?	N/A
	Road X Slope (%)	N/A	N/A	Clear Space to XWalk (in)	N/A
N/A	Any Obstructions?	N/A	N/A	Storm Grate/Utility Hazard?	N/A
	Obstruction Type			Storm Grate/Utility Type	
		N/A			N/A
			Yes	Surface Condition? (G/P)	Good

Possible Solutions:

**Remove & Replace Entire Ramp.**

**R304.5.1, R304.2.2**
